**ASHBY 'TOWN' CONSERVATION AREA  
CHARACTER APPRAISAL**

**DRAFT  
NOVEMBER 2023**

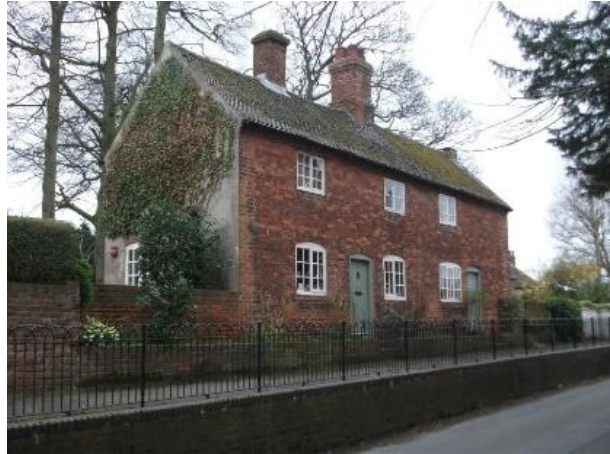
2.9. 1 and 3 Hill Street are grade II listed and they contribute positively to setting (pictured). Victorian development on Burton Road makes a neutral contribution. Generally modern development makes a negative contribution.

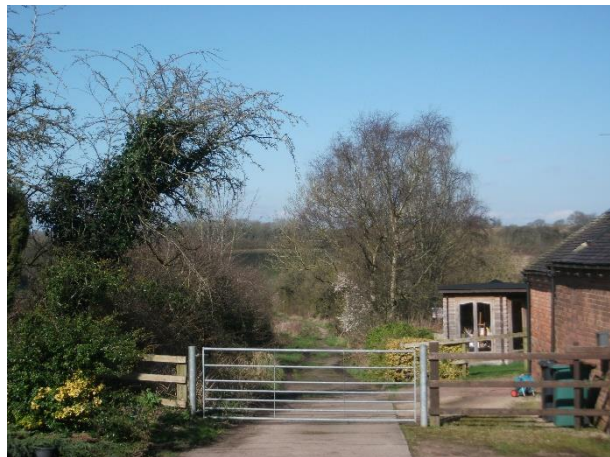
2.12. The access drive between 55 and 57 Wood Street offers a glimpse into countryside (pictured). This glimpse illustrates the historic relationship between the settlement core and the surrounding countryside. The District Council has permitted the erection of 605 dwellings on land at Money Hill (15/00512/OUTM). The master plan indicates that the access drive would be retained as a "pedestrian link" bounded by hedges.

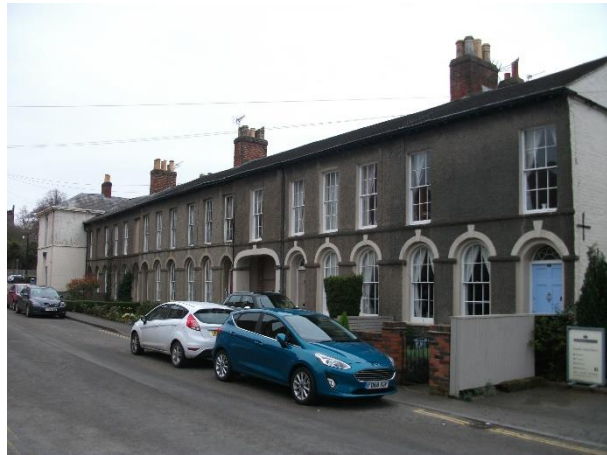
- o) Surface car park etc.: A surface car park and detached house laid out c.1923-71;
- p) 'Priest House' and 18 to 23 South Street: A detached house and a terrace (pictured) erected in the early or mid-nineteenth century;
- q) Telephone exchange etc.: A telephone exchange<sup>5</sup> erected c.1962 and four detached houses erected c.1923-71.

2.16. The 'Priest House' and 18 to 23 South Street are grade II listed and they contribute positively to setting. Generally the modern development makes a negative contribution.

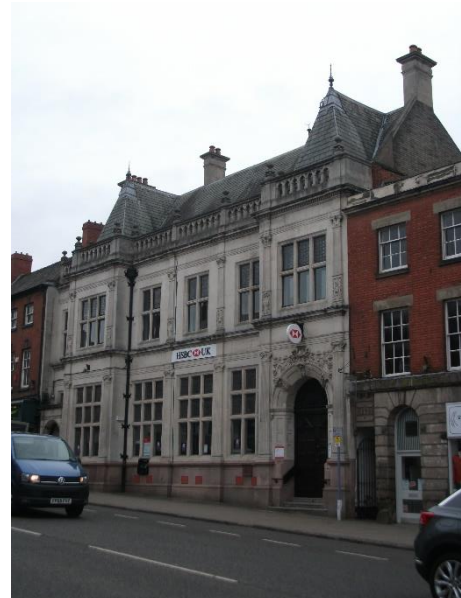
3.12. Map 7 indicates the limited number of properties that were erected within the settlement core during the period c.1884 to c.1923. Two of these properties are grade II listed. They are Prince William House on Lower Church Street and the former Leicestershire Bank on Market Street (pictured).

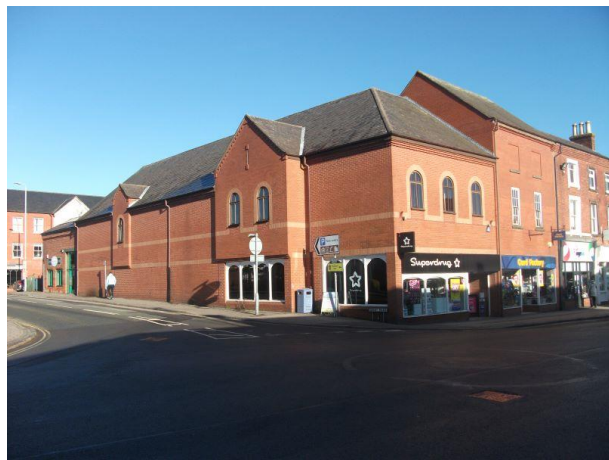
- g) Bath Street and Derby Road: Properties were demolished c.1906 for the Burton & Ashby light railway; public conveniences were erected c.1923-48. Further properties were demolished piecemeal after 1948 and replaced by shops (pictured right) and a 'mixed use building'<sup>17</sup>;

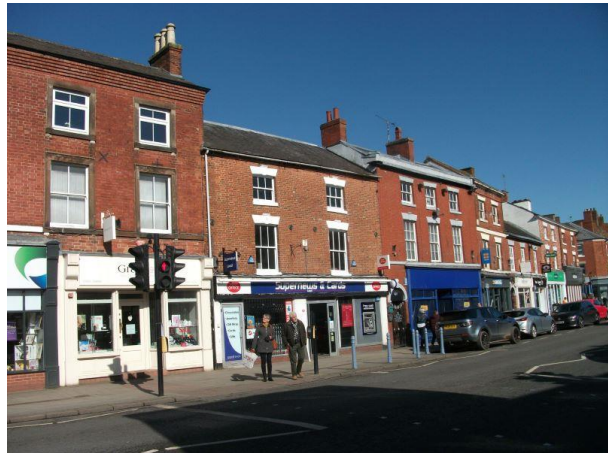
- 5.8.1. Generally buildings are arranged in terraced groups around a linear open space; some courtyard development survives. Generally buildings are three storeys tall. Most buildings are faced in red brick but a substantial minority are faced in render. The character zone contains 29 listed buildings.

- 5.8.2. Four buildings on the south side of Market Street do not contribute positively to character. In the long term there are opportunities to enhance character through the replacement of these buildings:

- **12 and 14 Market Street:** The building does not reflect the massing and materials of the character zone.
- **42 to 48 Market Street:** This large building does not reflect the scale of the character zone; it contributes negatively to views of the church tower from the west. 42 Market Street has an untreated aluminium shop front.
- **r/o 52 Market Street:** The building does not reflect the massing and materials of the character zone; the boundary treatment also contributes negatively.
- **1 Union Passage:** The single-storey flat-roofed structure to the rear of 28 to 32 Market Street does not reflect the scale and massing of the character zone.

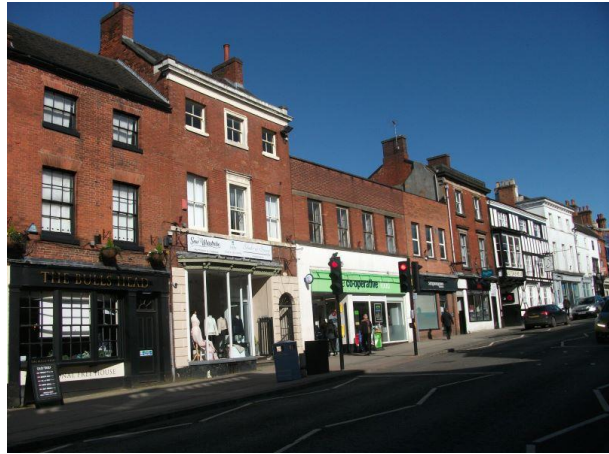
- 5.8.4. Generally buildings are arranged in terraced groups and laid out to the back of the pavement. Some courtyard development survives but much was demolished c.1948-71. Generally buildings are three storeys tall. Most buildings are faced in red brick but a substantial minority are faced in render. The character zone contains 22 listed buildings. The Bulls Head PH (67 Market Street) is a grade II\* listed building.

- 5.8.5. Two buildings in the character zone do not contribute positively to character. In the long term there are opportunities to enhance character through the replacement of these buildings:

- **57 and 59 Market Street:** This large building does not reflect the scale of the character zone.
- **73 and 75 Market Street:** The two-storey flat-roofed building does not reflect the scale and massing of the character zone.

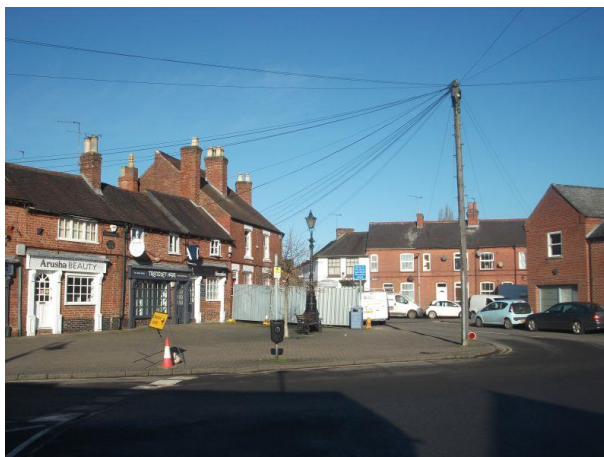
- 5.8.8. Generally buildings are arranged in terraced groups around an irregular open space (pictured right). Generally buildings are 1½ or 2 storeys tall. Generally buildings are faced in red brick. 8 to 12 The Green, 1 North Street and a former lamp standard are grade II listed buildings.

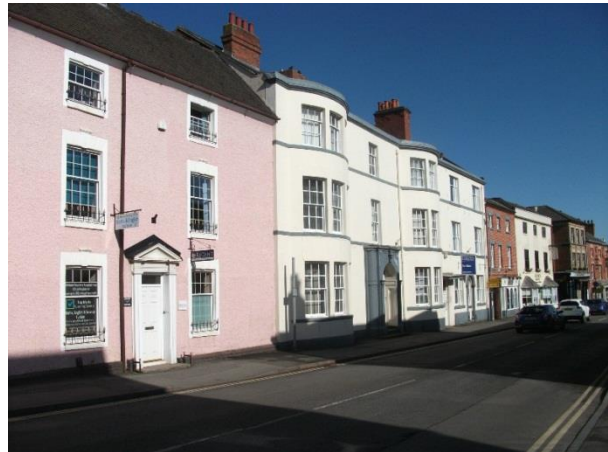
- 5.21.1. This character zone contains a diversity of uses. Generally buildings are arranged in terraced groups and laid out to the back of the pavement. Generally buildings are 3 storeys tall. Generally buildings are faced in render. The character zone contains 9 listed buildings.

- 5.21.2. A non-conformist chapel and school were demolished c.1985 and replaced by an access drive. In 1988 we permitted a large three-storey extension to the rear of the Fallen Knight PH (88/0059/L) and a pair of houses to the rear of Kilwardby Mews (88/0143/P). This development does not contribute positively to significance. In the long term there is an opportunity to enhance character through the redevelopment of the site.

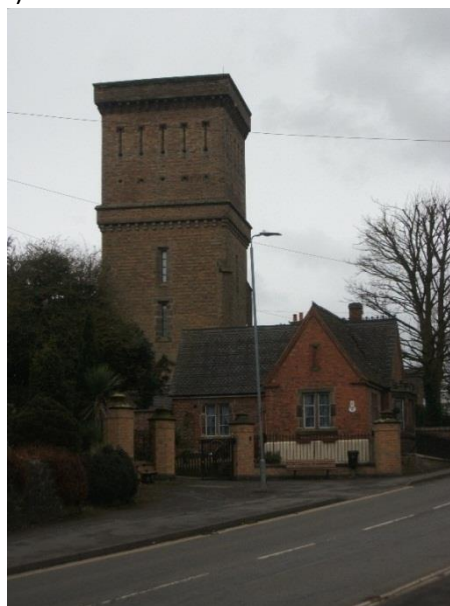
- The former **Water Tower** (pictured right) is a landmark in views looking west along Kilwardby Street. On the south side of Kilwardby Street the view is framed by a shelter belt of trees formerly associated with Hill House. The shelter belt is subject to a tree preservation order (TPO).

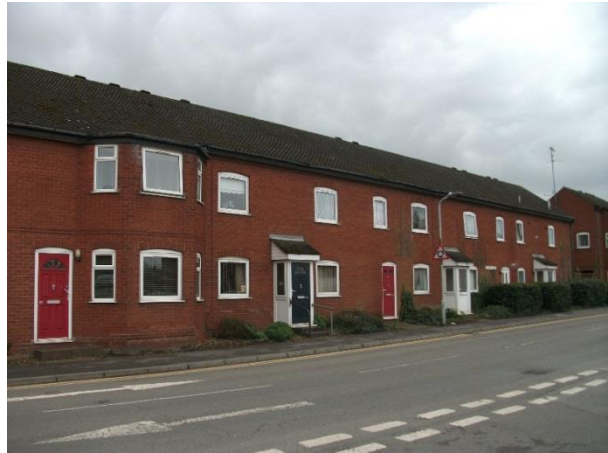
- 7.1. Properties including a ‘coal yard’ were demolished c.1978-81 and replaced by 28 flats. The flats are laid out behind shallow forecourts and introduce soft landscaping in a manner that does not reflect the ‘Green’ character zone. The flats are arranged in large blocks with unbroken eaves and ridge lines; they do not reflect the diverse height and massing of buildings in the ‘Green’ character zone.

- 7.2. 5A Brook Street was erected in 1979 (our ref 79/0672/R). It is subservient in scale to the principal building (5 Brook Street) but it does not reflect the height of buildings in adjoining character zones.
- 7.3. In the long term there is an opportunity to enhance character through the replacement of these buildings. The replacement buildings should reflect the layout of the ‘Green’ character zone. They should reflect the diverse height and massing of buildings in that character zone.

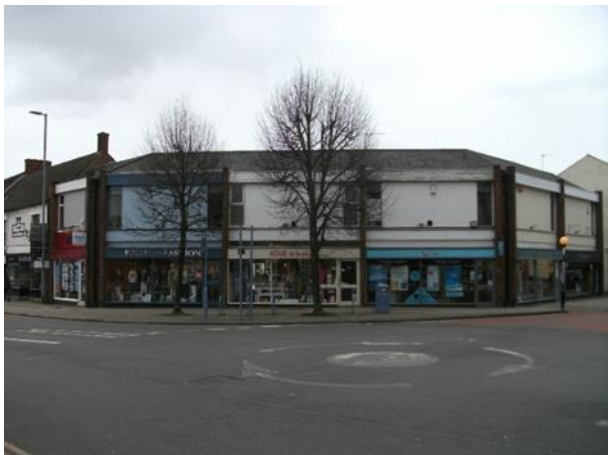
- 7.4. Properties were demolished c.1906 for the Burton & Ashby light railway; public conveniences were erected c.1923-48. Further properties were demolished piecemeal after 1948 and replaced by shops.
- 7.5. The public conveniences are laid out behind a shallow forecourt and they introduce soft landscaping in a manner that does not reflect adjoining character zones. They do not reflect the height of buildings in adjoining character zones. Land at the Shoulder of Mutton PH makes a neutral contribution to character but ‘hoop top’ railings are uncharacteristic.

- 7.6. 'Bath Street Corner' does not reflect the massing and materials of buildings in adjoining character zones. It is a 'cross wall' structure with a shallow pitched roof. 11 Market Street makes a neutral contribution to character but the previous character appraisal notes the "extensive blank façade" addressing Derby Road.
- 7.7. In the long term there is an opportunity to enhance character through the replacement of these buildings. The replacement buildings should reflect the character of the adjoining 'Bath Street' and 'Market Street west' character zones. They should be laid out to the back of the pavement; the opportunity to recreate the historic street layout should be explored. They should be faced in red brick. They should offer active frontages to each street elevation.

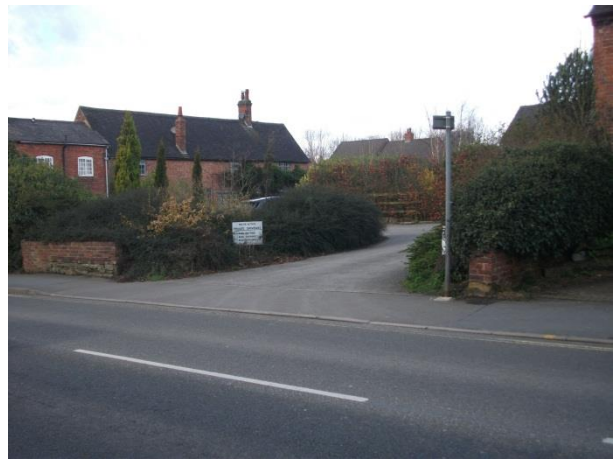
- 7.8. Properties were demolished c.1948-71. The site contains a large amount of soft landscaping that does not reflect adjoining character zones. The soft landscaping is dominated by cotoneaster and laurel while 47 & 49 Wood Street is bounded by a privet hedge.

- 7.9. In the long term there is an opportunity to enhance character through the redevelopment of the site. New buildings should reflect the adjoining 'Upper Church Street' and 'Wood Street east' character zones. New buildings should be laid out to the back of the pavement; they may reflect traditional courtyard development. They should be faced in red brick. They should reflect the diverse heights of buildings in the adjoining character zones. Redevelopment would offer an opportunity for the investigation of below-ground remains.

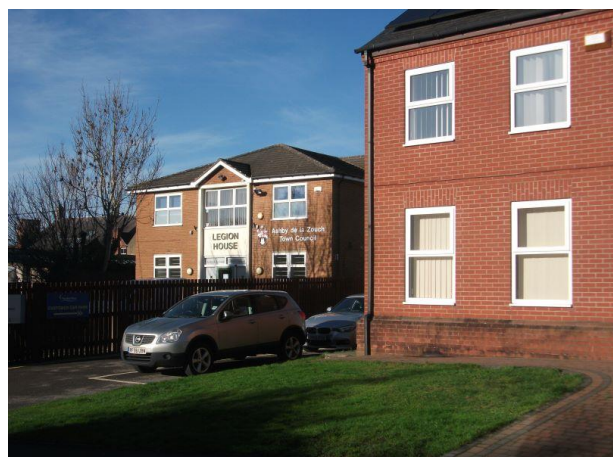
- 7.10. Properties were demolished c.1948-71; a club (now 'Legion House') opened in 1966. Legion House does not reflect the layout, massing or materials of adjoining character zones. Its layout does not reflect traditional court development. It has a shallow pitched roof, a deep roof span and a complex roof shape. It is faced in brown brick with a non-traditional roof covering.

- 7.11. To the rear of 76 Market Street, single-storey flat-roofed garages do not reflect the scale and massing of adjoining character zones. To the rear of 92 Market Street, a large flat-roofed building does not reflect the scale and massing of adjoining character zones. 'Castle Flats' and 'Castle House' make a neutral contribution to character.

- 7.12. In the long term there is an opportunity to enhance character through the redevelopment of the site. New buildings should reflect the adjoining 'Market Street east' and 'Lower Church Street' character zones. They should be laid out to the back of the pavement; they may reflect traditional courtyard development. They should be faced in red brick. They should be 2½ or 3 storeys tall.
- 7.13. 26 & 27 South Street were erected before 1884. This building contributes positively to character.

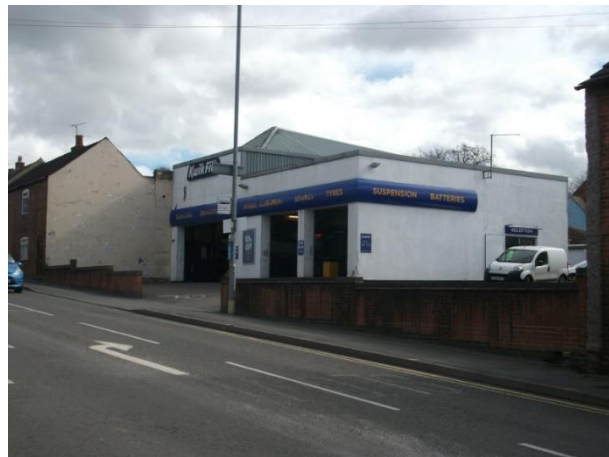
- 7.14. On the north side of the street, 29 Wood Street was demolished and replaced c.1948-71 by a 'depot'. On the south side of the street, a garage was erected c.1923-48. 16 to 20 Wood Street were demolished in 1960. In all respects the development does not reflect adjoining character zones.

- 7.15. In the long term there is an opportunity to enhance character through the replacement of these buildings. The replacement buildings should reflect the character of the adjoining 'Upper Church Street' and 'Wood Street west' character zones. They should be laid out to the back of the pavement; they may reflect traditional courtyard development. They should be faced in red brick. They should be 1½ or 2 storeys tall.

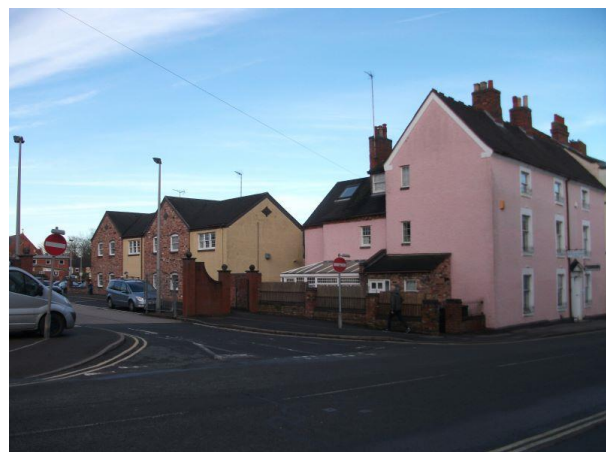
- 8.2. On the north side of Kilwardby Street [a] a non-conformist chapel and school were demolished c.1985 and replaced by an access drive. In 1988 we permitted a large three-storey extension to the rear of the Fallen Knight PH (88/0059/L) and a pair of houses to the rear of Kilwardby Mews (88/0143/P). This development does not contribute positively to significance. Replacement buildings should reflect the character of the 'Kilwardby Street east' character zone.

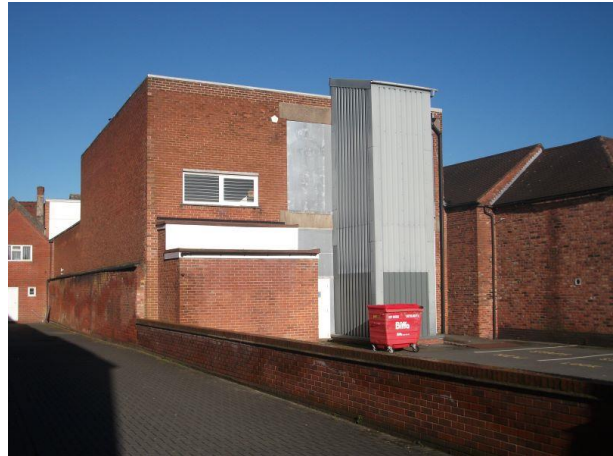
c) **12 & 14 Market Street:** The building does not reflect the massing and materials of the character zone. A shallow pitched roof addresses Market Street and a flat roof addresses South Street. The rear elevation contains non-traditional facing materials (pictured right).

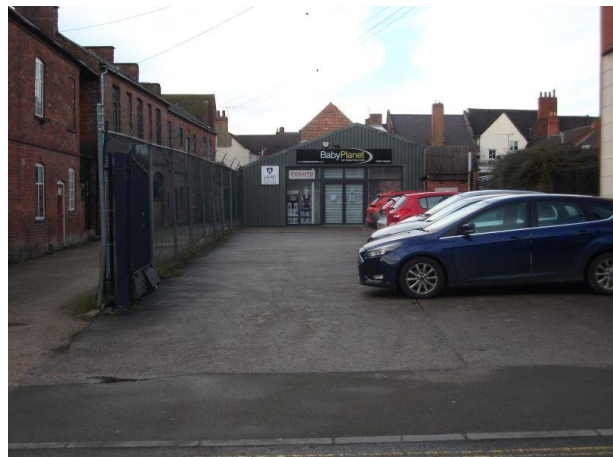
f) **r/o 52 Market Street:** The building does not reflect the massing and materials of the character zone. It has a shallow pitched roof and a deep roof span. It uses non-traditional facing and roofing materials. The boundary treatment also contributes negatively and in the short term there is an opportunity to enhance character through its replacement.

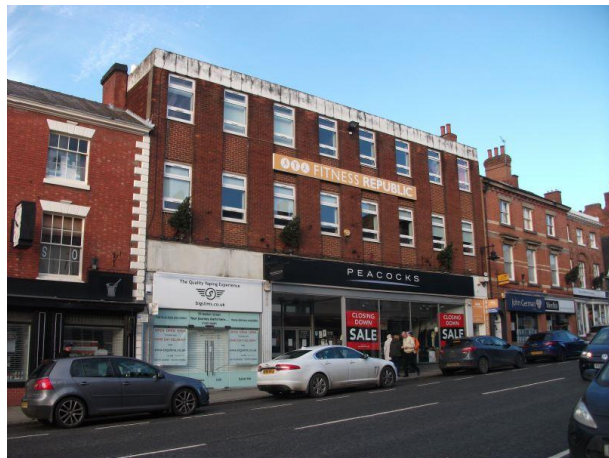
g) **57 & 59 Market Street:** This large building does not reflect the scale and massing of the character zone (pictured). It is 'double width' (i.e. it occupies two traditional plots) and it is more than three storeys tall. It has a flat roof.

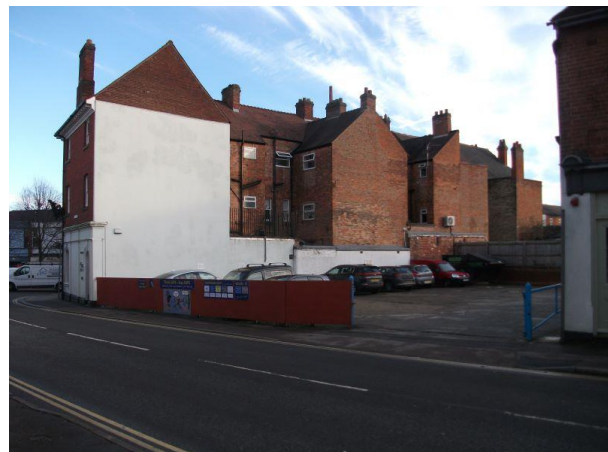
k) **Kilwardby Street south:** Buildings were demolished after 1923 and replaced by a surface car park. Replacement buildings should reflect the character of the Kilwardby Street south character zone. In 2017 the District Council permitted the erection of a three-storey building containing a mix of uses (our reference 17/00430/FUL).

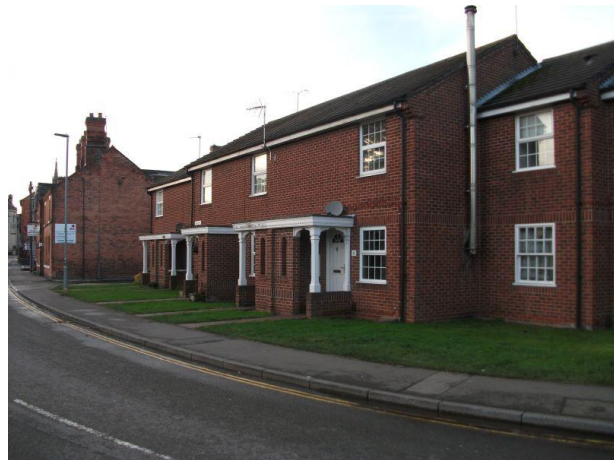
8.9. Front gardens at ‘Ivanhoe Terrace’ contribute positively to character. Gardens are bounded by a mix of palisade railings and privet hedges. ‘Loudoun Court’ offers an opportunity to enhance character through the introduction of similar boundaries.

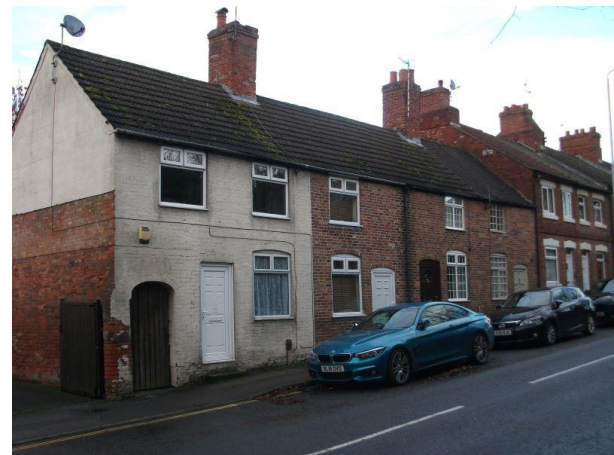
8.11. Non-traditional roofing materials intrude to a greater extent in the ‘Upper Church Street’ and ‘Wood Street west’ character zones. These character zones offer an opportunity to enhance character through the reinstatement of traditional roofing materials.

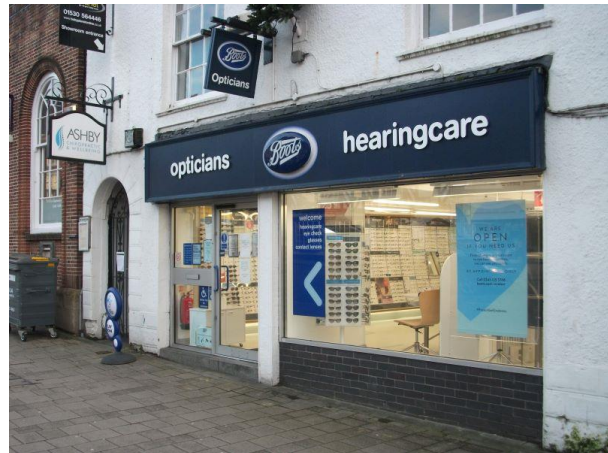
8.12. The use of render or the use of a non-traditional roofing material may appear more jarring where it is used on part of a terrace or on one half of a symmetrical pair. On this basis the ‘Upper Church Street’ character zone offers four opportunities for enhancement:

- 1 to 7 Leicester Road (pictured);
- 9 to 23 Leicester Road;
- 1 to 5 Upper Church Street;
- 38 to 48 Wood Street.

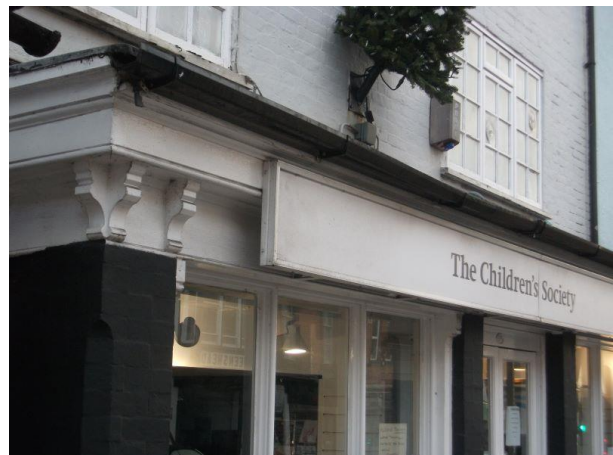
- Two listed buildings contain untreated aluminium shop fronts (52 Market Street (pictured); 63 Market Street).

- The terraced group 15 to 33 Market Street contains several large fasciae. 33 Market Street has a very large fascia that extends over the first floor window sills.
- At 94 and 96 Market Street fascia signs have been installed in a manner that obscures the frieze and cornice (pictured below). At 50 and 84 Market Street panel signs have been attached to buildings "where there is no fascia".
- Lettering should be painted directly onto the shop front rather than on a board which is then stuck on; 72 Market Street is an example of bad practice.

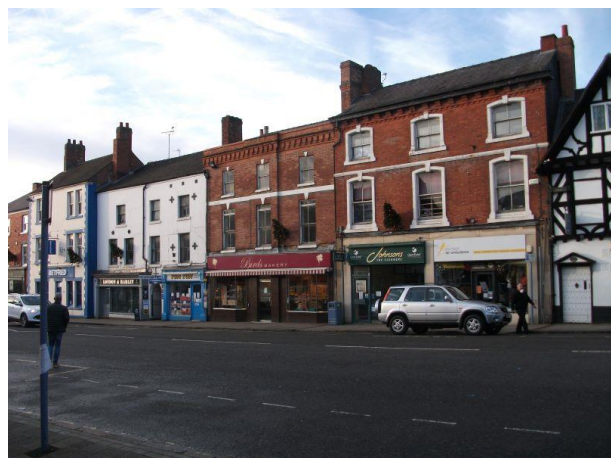
- Three listed buildings in the ‘Market Street west’ character zone were found to be vulnerable (20 Market Street; 47 Market Street; 50 Market Street). The terraced group 43 to 49A Market Street (pictured right) was found to be in fair condition<sup>28</sup>.
