**HEMINGTON CONSERVATION AREA  
CHARACTER APPRAISAL**

**DRAFT  
NOVEMBER 2023**

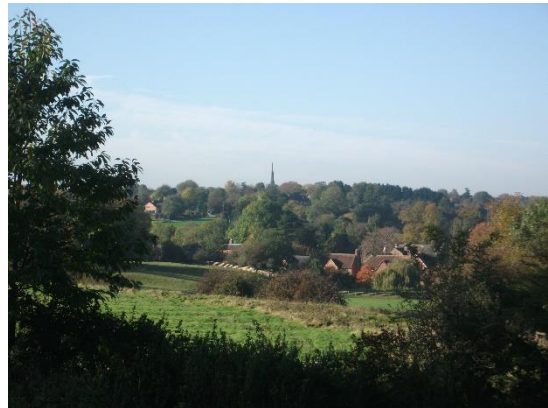
2.10. Undeveloped land adjoins the conservation area to the east (pictured). From north to south the land rises from 35m AOD to above 50m AOD. It is bisected by a public footpath that runs east-west and offers views toward the 'shelter belt', Hall Gardens and the spire of Castle Donington parish church beyond.

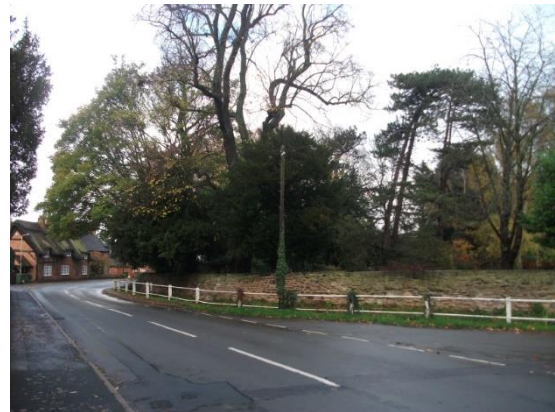
- 5.8. 2 and 2A Main Street were erected c.1964. The houses are faced in red brick beneath non-traditional roof coverings; they do not contribute positively to character<sup>23</sup>. The houses reflect the density and layout of houses on Main Street.

<sup>23</sup> NWLDC (2001) said that the houses were "suburban in character" and "paid little regard to the materials of existing buildings within the village".

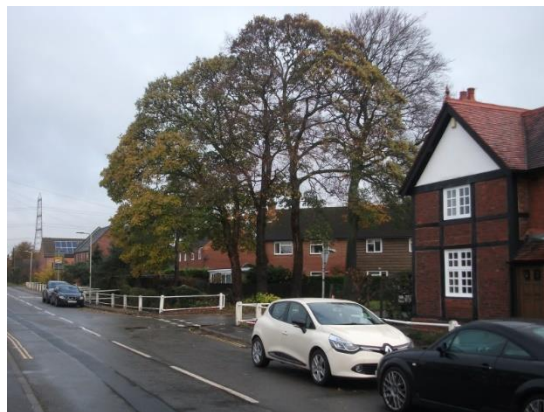
- 6.5. In July 1897 the play area on Lockington Lane was given to the village. 2 Lockington Lane was erected c.1990 on a portion of the 'shelter belt' (our reference 90/0091/R). The front boundary contains three mature horse chestnut trees and two mature lime trees. The trees contribute positively to character; 2 Lockington Lane makes a neutral contribution.

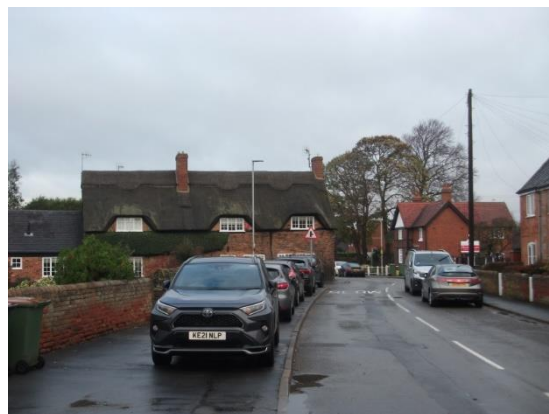
- 7.2. 37 Main Street is a landmark in views north along Main Street. The view extends beyond the house to include a group of trees at the corner of Lockington Lane and Main Street. The side elevation of the house forms a 'pinch point' that defines the north entrance to the conservation area<sup>27</sup>.

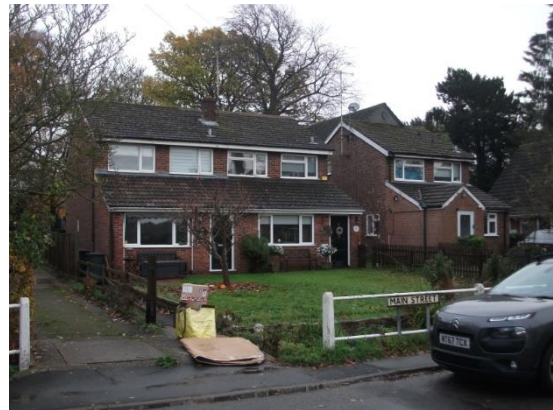
- 8.6. Three houses were erected c.1963-74. Each house is two storeys tall with a single storey lean-to element in front. Each house has a non-traditional roof covering. The houses do not reflect the massing or materials of traditional buildings on Main Street.

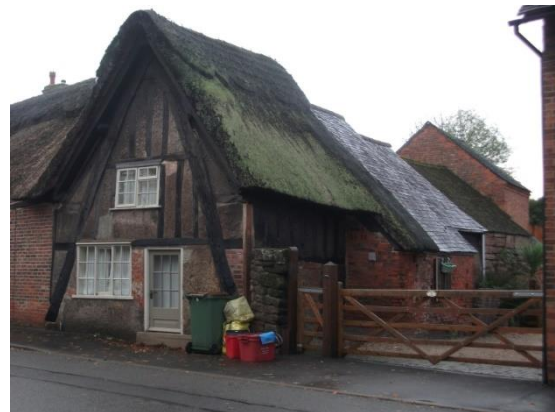
9.5. In 2005-06 the County Council assessed the condition of 15 listed buildings in the Hemington conservation area<sup>29</sup>. 11 buildings (73.3%) were found to be in good condition; 1 building (6.7%) was found to be in fair condition and 3 buildings (20%) were found to be in poor or very bad condition.

9.6. In 2017 the District Council assessed the condition of the same 15 listed buildings<sup>30</sup>. 10 buildings (66.7%) were found to be in good condition; 4 buildings (26.7%) were found to be in fair condition and 1 building (6.7%) was found to be in poor condition. In 2017 the following listed buildings were found to be either 'at risk' or 'vulnerable':

- A boundary wall at Peggs Farmhouse ('at risk');
- 7 Main Street ('vulnerable');
- An outbuilding at 7 Main Street ('at risk');
- A boundary wall at Hemington Hall ('at risk');
