**IBSTOCK CONSERVATION AREA
CHARACTER APPRAISAL**

**ADOPTED
OCTOBER 2017**

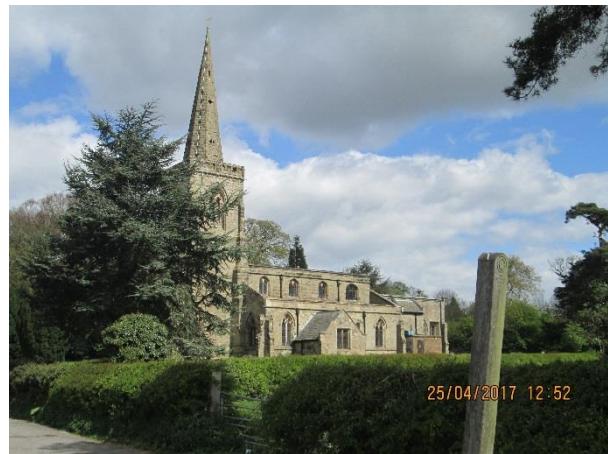
- 3.7. Ibstock appears in the Domesday Book of 1086 as *Ibestoche*. While the Church of St Denys (pictured) is “almost entirely of the early fourteenth century”, it is considered “probable that a Norman church stood on the present site” (Pevsner, 1984; Armson, 1938).

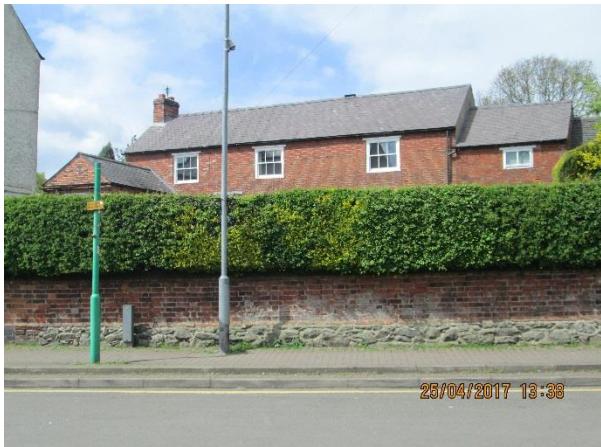
- 3.15. Fourthorn Farm (pictured) dates to the early eighteenth century. Cawte (2000) says that “the earliest known deeds are 1735”. The Manor House was altered substantially in the mid eighteenth century; Cawte (2000) identifies a Georgian wing, “probably built by Joseph Paget, who bought the property in 1748”. The house was known as Ibstock House until c.1901-03.

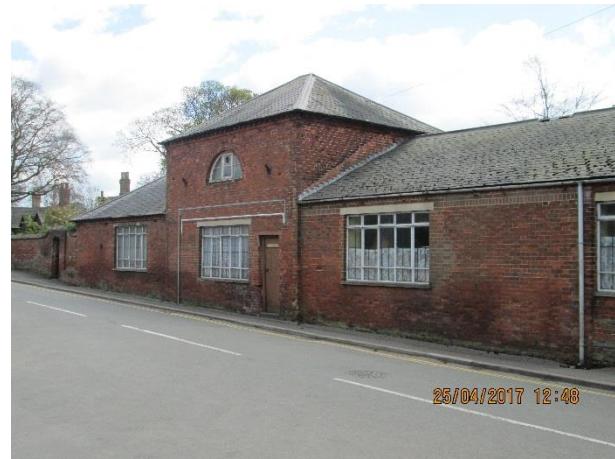
- 4.3. In 1954 permission was granted for the subdivision of the rectory into two dwellings (our reference IB54/4198). A coach house was altered to form a church hall³. The church hall (pictured) opened in October 1958.

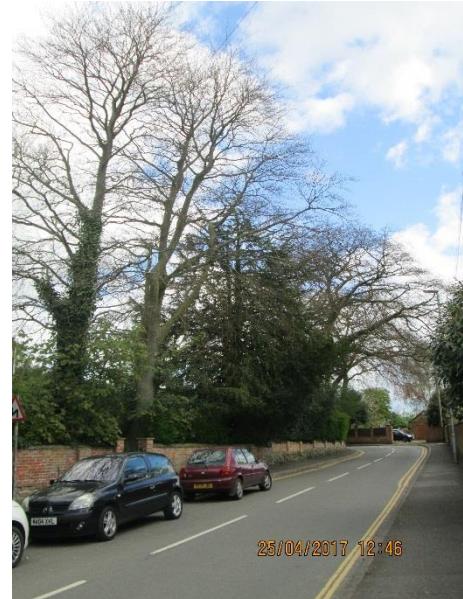
- 5.12. These two properties occupy a sparsely developed zone that separates the High Street from the group of properties around Hall Street. The properties are set back from the street behind large front gardens. Boundary walls and soft landscaping make a substantial contribution to the character of this zone; note a group of beech trees in the gardens of the two properties (pictured).

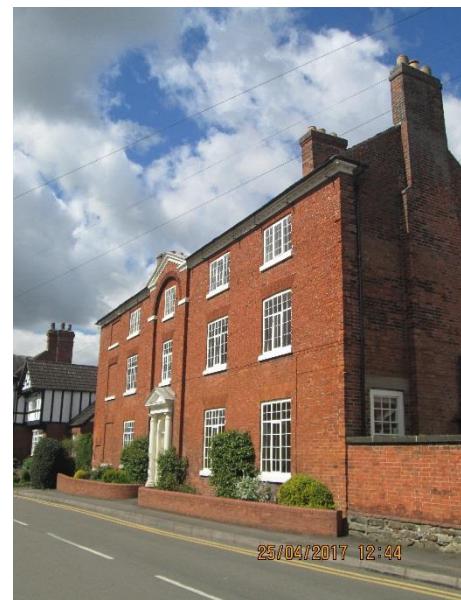
- 5.20. Properties in this character zone are generally two storeys in height. Taller buildings have landmark value; they include Holmsdale Manor (pictured), 111 High Street and 121 High Street. The majority of properties are faced in red brick but a substantial minority are rendered. The majority of properties have slate roofs; non-traditional roof coverings intrude to a lesser extent.

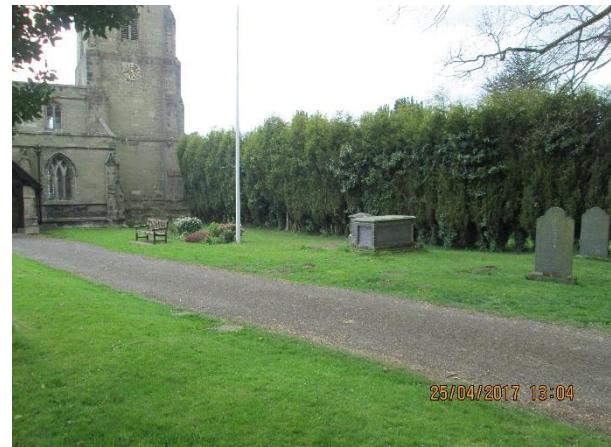
- 8.11. The churchyard is bisected by a coniferous hedge (pictured); visually it does not contribute positively to the conservation area. There is an opportunity to enhance the significance of the conservation area by replacing this hedge with (e.g.) a broad leaved evergreen hedge.

- 6.4. The churchyard is bisected by a coniferous hedge. It may alleviate noise from Hinckley Road but visually it does not contribute positively to the conservation area.
