Air Quality Review and Assessment

Detailed Assessment

Environmental Protection Section
Planning and Environment
Council Offices, Coalville,
Leicestershire, LE67 3FJ

April 2005

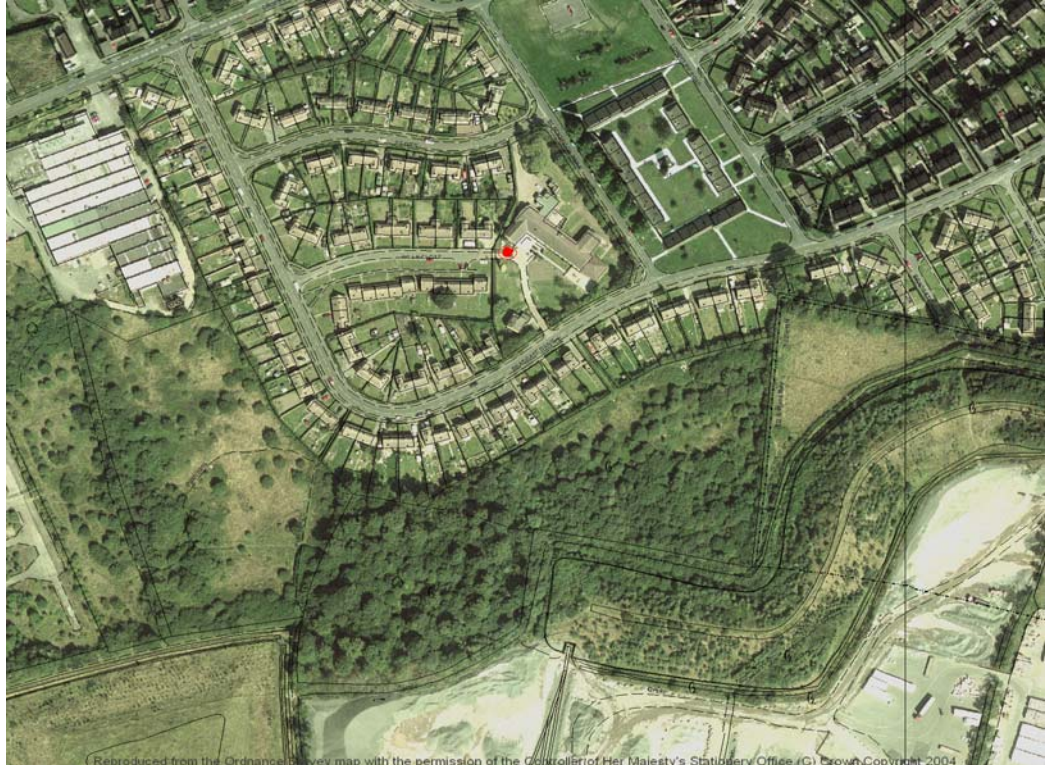
Figure 1.1 Location of Tillson House showing proximity to Bardon Quarry

The Updating and Screening Assessment examined all relevant domestic and industrial sources of PM₁₀ that may affect the detailed assessment area and concluded that no other significant sources of PM₁₀ were present. As a result Bardon Quarry is considered to be the main source of PM₁₀ in the immediate vicinity. The location of the PM₁₀ monitors at Tillson House is indicated by the red mark on Figure 1.1.

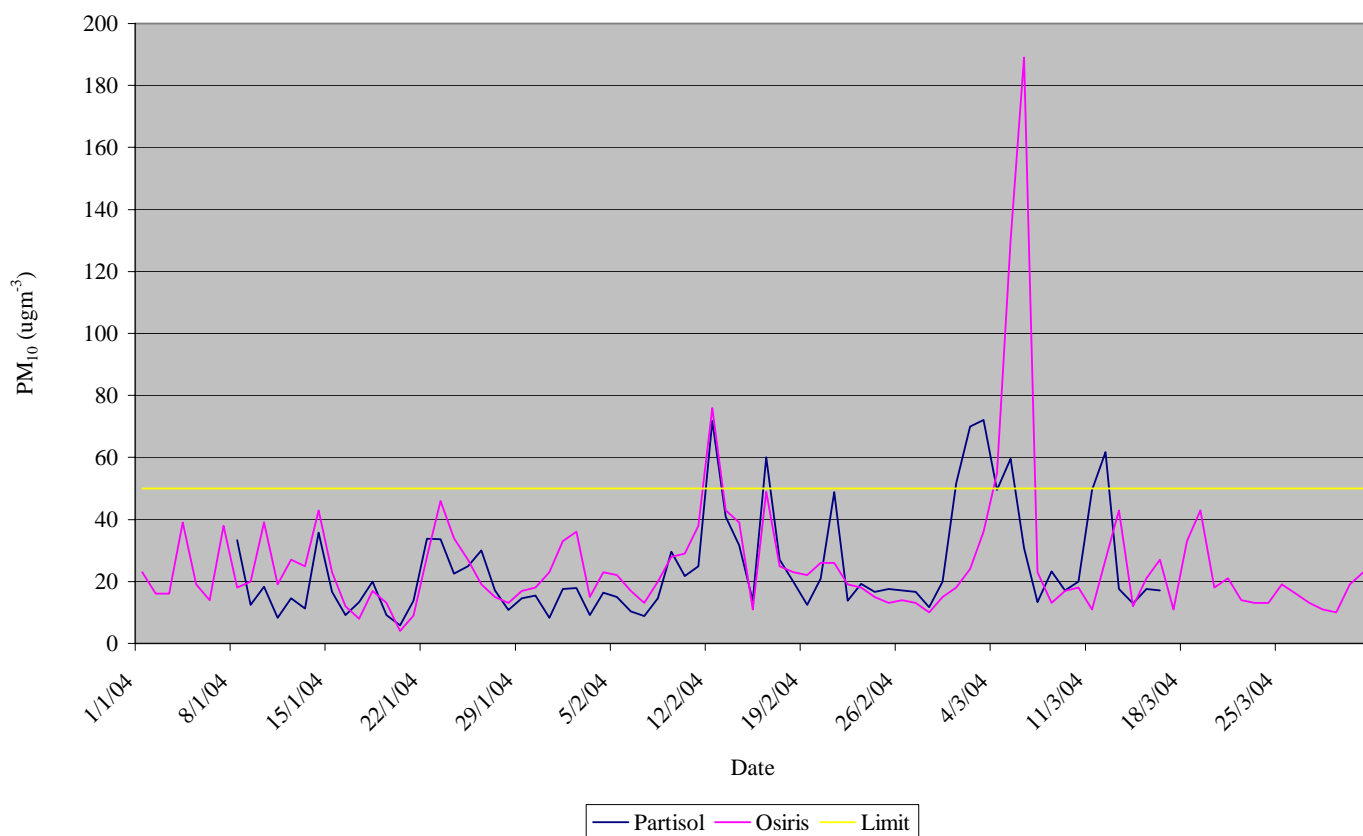
Figure 2.1 PM₁₀ Concentrations ($\mu\text{g}\text{m}^{-3}$) Recorded by the Partisol and Osiris PM₁₀ Monitors During the Initial Study Period

PM₁₀ sampling was undertaken between 10th December 2003 and 16th March 2004, during which a total of 92 days sampling was achieved out of a total of 97 days, which equated to approximately 95% data capture the results of which are displayed in Figure 2.1. During the sampling period 11 exceedences of the 50µgm⁻³ limit set within UK National Air Quality Strategy and EU Air Quality Daughter Directive (DEFRA, 2001) were registered at Tillson House by the Partisol PM₁₀ analyser. The number of exceedences recorded by the Partisol equates to, in excess, of 40 exceedences per annum, greater than the 35 permitted within the 2004 objective of the Strategy. However, there could be seasonal variation, which may either dictate an increase or decrease of this ratio.

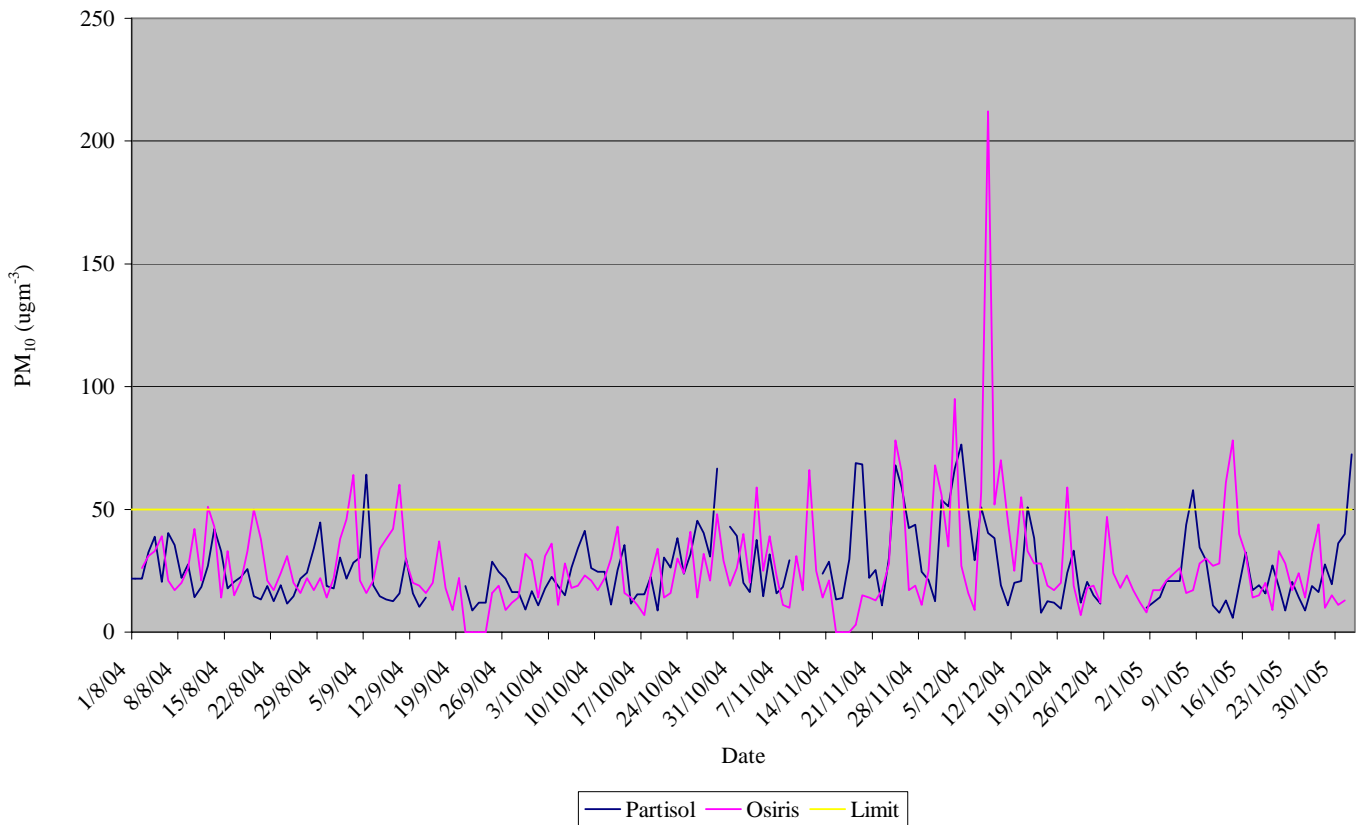
Figure 4.1 PM₁₀ Concentrations (μgm^{-3}) recorded by the Partisol and Osiris PM₁₀ Monitors during the 6-month Study Period

The extended period of gravimetric sampling in conjunction with real time data and wind data commenced in August 2004. The results of the monitoring are displayed in Figure 4.1. During the 6-month study period the Partisol PM₁₀ analyser recorded 16 exceedences of the 50µgm⁻³ limit as set within the UK National Air Quality Strategy. During the same period the Osiris PM₁₀ analyser recorded 17 exceedences of the 50µgm⁻³ limit of which 5 exceedences were recorded during the same 24hr period by both the Partisol and Osiris. Overall for the monitoring period January 2004 to January 2005 the Partisol recorded 21 exceedences of the 50µgm⁻³ limit whilst the Osiris recorded 23 exceedences.
