**CASTLE DONINGTON CONSERVATION AREA
CHARACTER APPRAISAL**

**ADOPTED
MAY 2023**

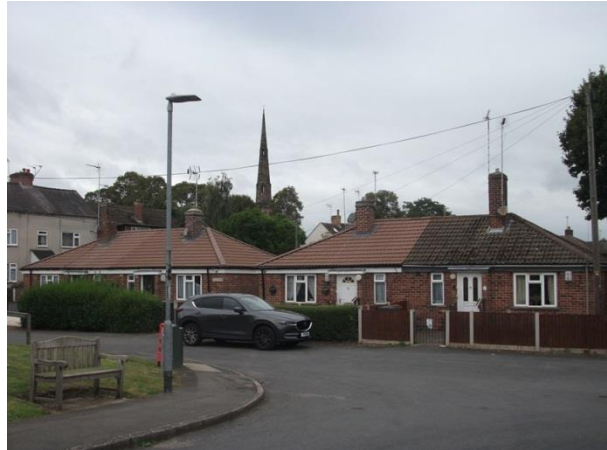
- 2.11. Generally the east side of the conservation area is bounded by sites that were redeveloped for housing after c.1921 (pictured right)².

Generally the housing sites make a negative contribution to the setting of the conservation area; there are direct connections between the housing sites and the conservation area. The sites are as follows:

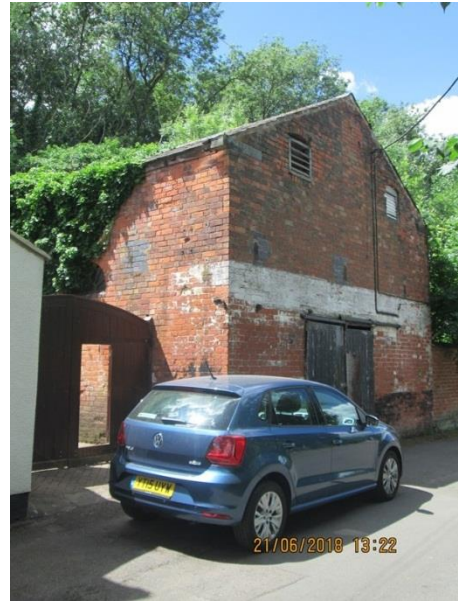
- 8) Gas works (pictured right): Gas works were established in 1853 (Kelly, 1899).
- 9) Silk mill: The silk mill appears in the 1871 census. In 1877 it was described as 'recently erected' (White, 1877).
- 10) Manor House: In about 1850 the Rawdon Hotel was converted into a house and "the village green that lay in front of it was enclosed as a front garden" (Lee, 1956).

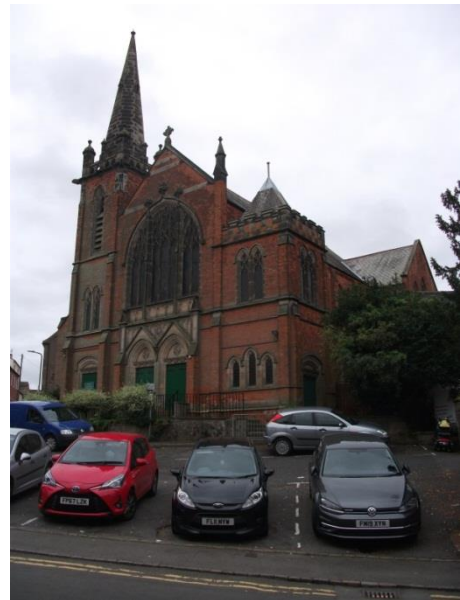
3.12. Map 2 indicates the limited number of properties that were erected within the settlement core during the period 1884 to 1921. Two of these properties are grade II listed. They are the former Baptist church hall on Bondgate and the Methodist chapel on Market Place (pictured right).

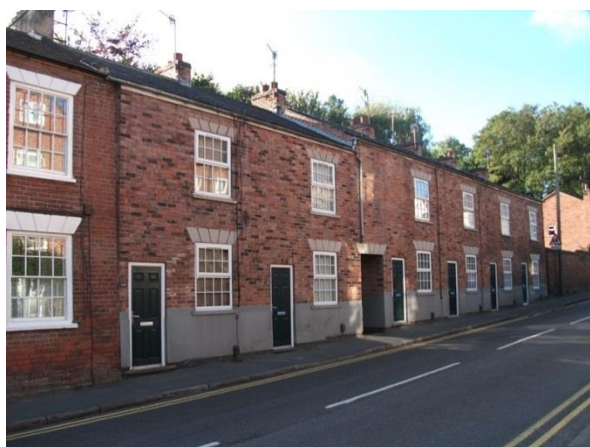
- d) Bondgate: Properties on the west side of Bondgate were demolished c.1921-61 and replaced with two detached houses and garden land¹⁰.
 - e) 28 to 44 Bondgate (pictured right): Properties were demolished in the late twentieth century and rebuilt in facsimile (Ryder, 1997).

- 8.4. 28 to 44 Bondgate were demolished in the late twentieth century and rebuilt in facsimile (Ryder, 1997). They make a neutral contribution to character.

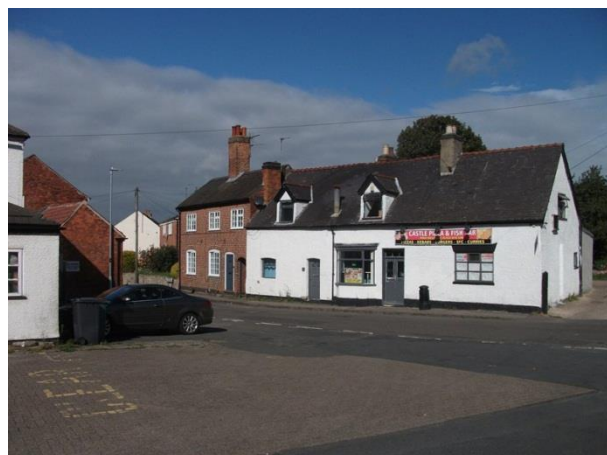
- 5.8. This character zone contains a mix of houses and other town centre uses. Most buildings here are laid out to the back of the pavement. The character zone contains a diversity of facing materials including red brick and render. Most buildings here are two storeys tall and have slate roofs. About 80% of buildings in this character zone have timber windows.

- 5.9. Generally this character zone contains buildings that contribute positively to character. The character zone contains no listed buildings.
- 5.10. The Castle Inn was demolished in 1962 (Cantrill, 1984). The building was replaced by a surface car park that does not contribute positively to character. In the short term there is an opportunity to enhance character using boundary treatments and soft landscaping. In the long term there is an opportunity to enhance character substantially through redevelopment of the site.

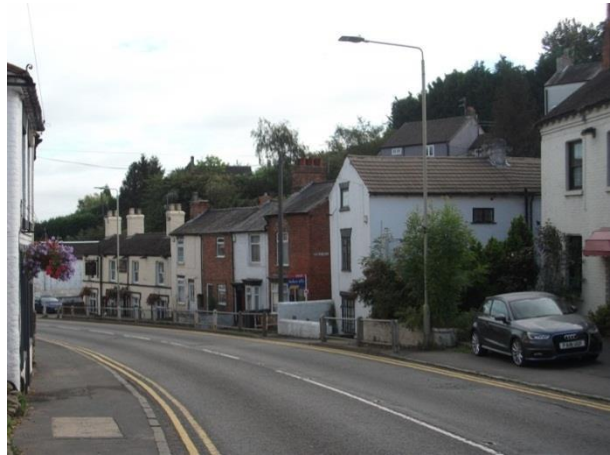
- 5.11. This character zone contains a mix of houses and other town centre uses. Most buildings here are laid out to the back of the pavement or behind shallow forecourts. Most buildings here are two storeys tall. The character zone contains a diversity of facing materials including painted brick and render. Non-traditional roof coverings intrude into this character zone.

- 5.12. Generally this character zone contains buildings that contribute positively to character. 'Crown House' is a grade II listed building.
- 5.13. Properties including a pinfold were demolished c.1963-72 and replaced with a pocket park. The openness of the pocket park contributes positively to character and to views of the parish church spire from Station Road (see paragraph 7.1ff).
- 5.14. 101 Bondgate does not contribute positively to character. It is a modern building that does not reflect the layout of the character zone. It is a single-storey building that features a flat roof. In the short term there is an opportunity to enhance character by introducing a gabled roof with a traditional roof covering. In the long term there is an opportunity to enhance character substantially through the replacement of the building.

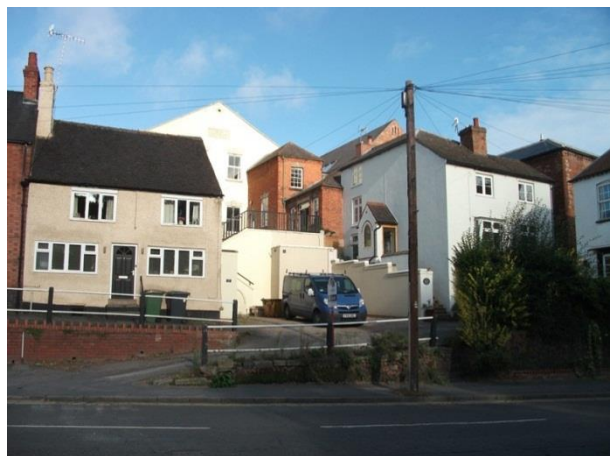
- 5.15. This character zone is in residential use. Most buildings here are set back from the street, often at an acute angle, reflecting the local topography. Bondgate 'south' reflects the diverse scale and materials of the remainder of the conservation area.
- 5.16. Generally this character zone contains buildings that contribute positively to character. The character zone contains four listed buildings.

- 5.17. 17 Bondgate does not contribute positively to character. It is a modern building that does not reflect the layout of the character zone. The layout introduces soft landscaping in a manner that does not reflect the character zone generally. The building is one and a half storeys tall. In the long term there is an opportunity to enhance character substantially through the replacement of the building.

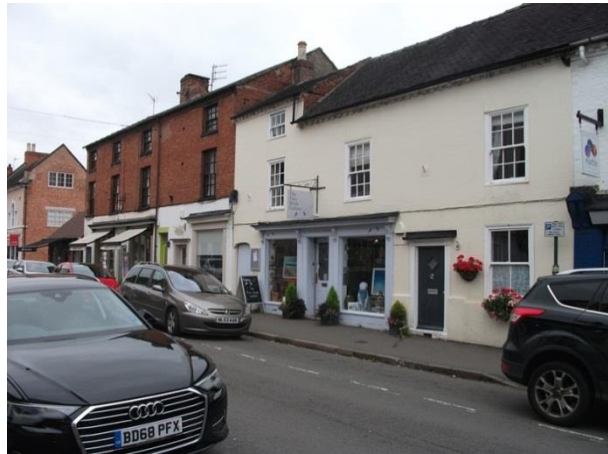
- 5.18. This character zone contains retail and other 'A' class uses. Most buildings here are laid out to the back of the pavement. Most buildings here are three storeys tall. The character zone contains a diversity of facing materials including red brick and painted brick. Non-traditional roof coverings intrude into this character zone. On the south-east side of Borough Street, the roofs of three-storey buildings are generally concealed from view.

- 5.19. Generally this character zone contains buildings that contribute positively to character. The character zone contains six listed buildings.
- 5.20. 35 Borough Street does not contribute positively to character. It is a modern building. It is one and a half storeys tall beneath a flat roof. In the short term there is an opportunity to enhance character by introducing a gabled roof with a traditional roof covering. In the long term there is an opportunity to enhance character substantially through the replacement of the building.

- 5.21. At 42 Borough Street a single-storey element with a flat roof does not contribute positively to character²². In the long term there is an opportunity to enhance character through the demolition of this element and the restoration of the principal building.

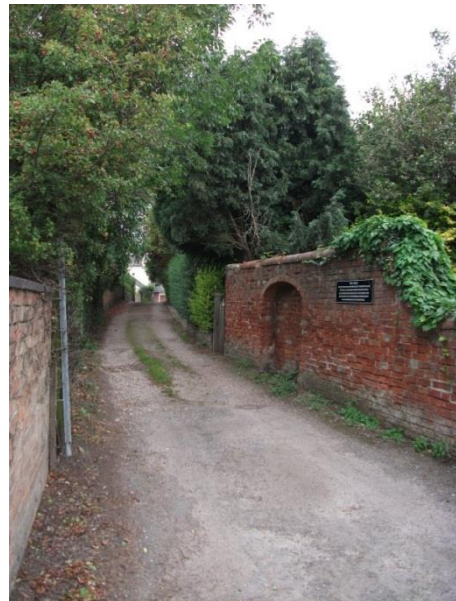
- 5.27. Castle Hill is a narrow street; it is not surfaced in tarmac and it does not have kerbs or markings. On its east side the street is bounded by a red brick wall. These qualities contribute positively to the character of the conservation area. Land at 14 Castle Hill appears untidy and a cedar has been condemned.
- 5.28. Moat is a narrow street; it is not surfaced in tarmac and it does not have kerbs or markings. These qualities contribute positively to the character of the conservation area. On its east side the street is bounded by fences at 13 to 21 Barroon. Replacement of this boundary treatment with a thorny hedge would enhance the character of the conservation area.

- 5.29. On the east side of Hillside properties are retained by a stone wall that contributes positively to the character of the conservation area. The properties are bounded by a thorny hedge. The hedge is ‘gappy’ and outgrown and contains weed species including ivy and bramble. In places the hedge is suppressed by conifers. Removal of the conifers and proper maintenance of soft landscaping would enhance the character of the conservation area.

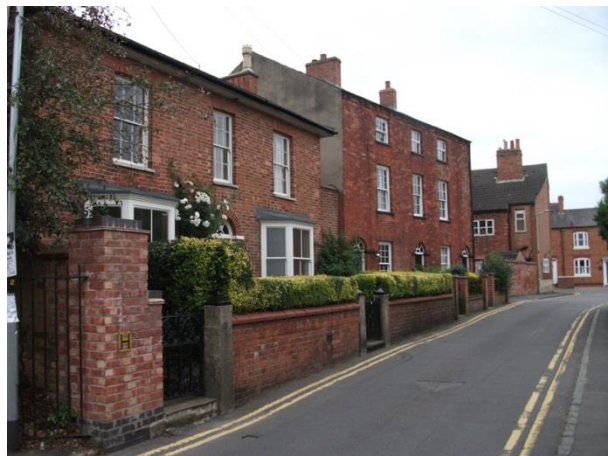
- 5.35. This character zone was developed after 1779; most buildings here date to the early nineteenth century. This character zone is in residential use. Most buildings here are laid out to the back of the pavement or behind shallow forecourts. Dovecote reflects the diverse scale and materials of the remainder of the conservation area.

- 5.36. Generally this character zone contains buildings that contribute positively to character. ‘Cranford’ is a grade II listed building.

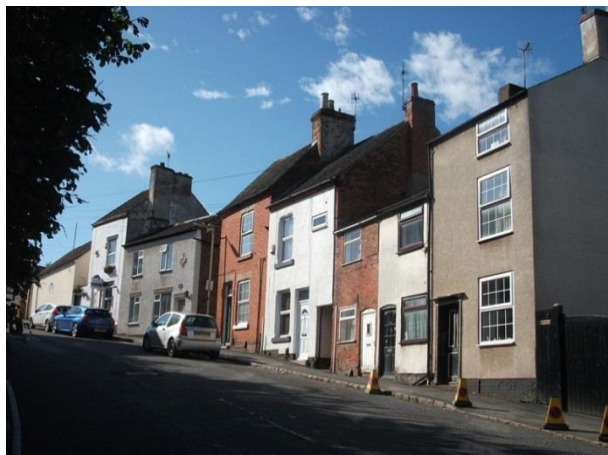
- 5.37. This character zone contains a mix of houses and other town centre uses. Most buildings here are laid out to the back of the pavement. Most buildings here are two storeys tall. The character zone contains a diversity of facing materials including red brick, painted brick and render.

- 5.38. Generally this character zone contains buildings that contribute positively to character. The character zone contains two listed buildings, ‘The Willows’ and 61 & 63 Borough Street.

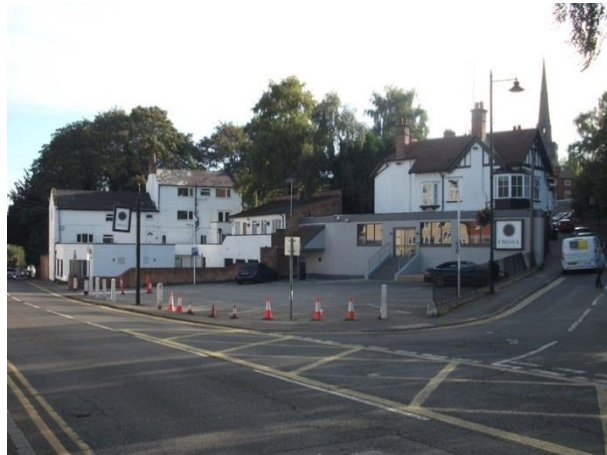
- 5.43. Buildings at the corner of Bondgate and Market Street²⁵ were demolished c.1921-63. The buildings were replaced by a surface car park that does not contribute positively to character. In the short term there is an opportunity to enhance character using boundary treatments and soft landscaping. In the long term there is an opportunity to enhance character substantially through redevelopment of the site.

- j) **Bondgate surface car park:** Buildings were demolished c.1921-63 and replaced by a surface car park. A replacement building should reflect the qualities of the Hotel character zone.

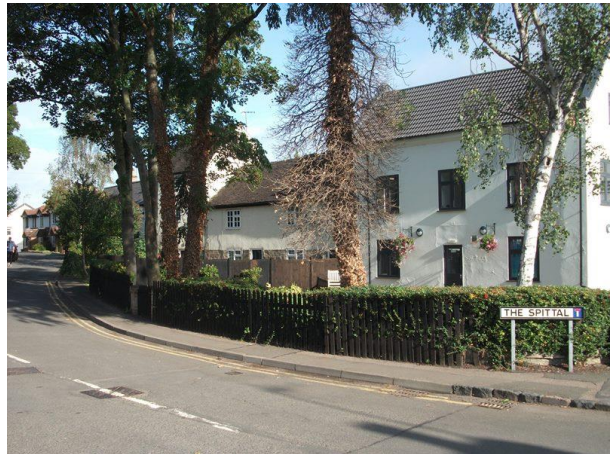
- 5.46. This character zone is in residential use. Most buildings are laid out to the back of the pavement or behind shallow forecourts. Most buildings here are faced in render. Non-traditional roof coverings intrude into this character zone. About 70% of buildings in this character zone have plastic windows.
- 5.47. Generally this character zone contains buildings that contribute positively to character. 4 & 6 Spittal is a grade II listed building.

- 5.48. Ash and other trees in front of the parish hub appear neglected; proper maintenance of trees would enhance the character of the conservation area.

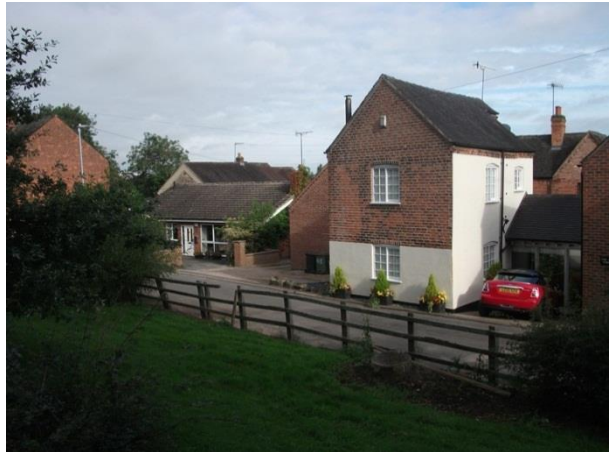
- 5.49. This character zone is in residential use; buildings are laid out along Spittal and around a cul-de-sac. Along Spittal most buildings are laid out to the back of the pavement but the cul-de-sac is sparsely developed. Most buildings here are two storeys tall. Most buildings here are faced in red brick and have plain tile roofs. Non-traditional roof coverings intrude into this character zone.

- 5.50. Within this character zone the street is narrow and it does not have kerbs or markings. On the north side of the street development is laid out to the back of the carriageway. On the south side of the street the grass verge adjoins the open space at Spittal Hill. These qualities contribute positively to the character of the conservation area.

- 5.51. Generally this character zone contains buildings that contribute positively to character. 52 Spittal is a grade II listed building.
- 5.52. 52A Spittal does not contribute positively to character. It is a modern building that does not reflect the layout of the character zone. It is a single-storey building with a non-traditional roof covering. In the short term there is an opportunity to enhance character by introducing a traditional roof covering. In the long term there is an opportunity to enhance character substantially through the replacement of the building.

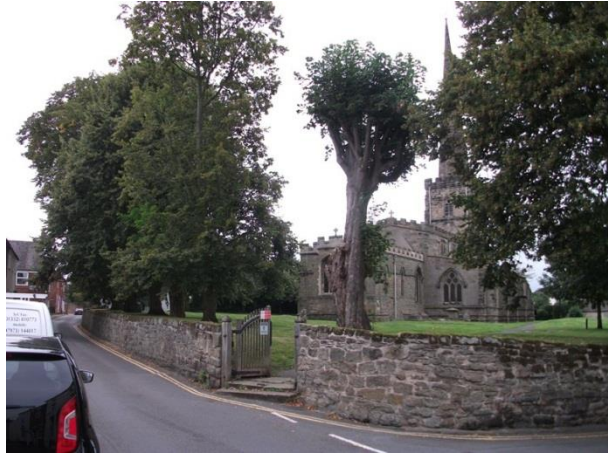
- 6.2. The chancel of the parish church was built in the early or mid-thirteenth century. The enclosure award map (1779) indicates the present extent of the churchyard. On Church Lane and Clapgun Street the churchyard is retained by stone walls; there are timber pedestrian gates at the east and south corners. On Borough Street a stone entrance screen was erected in the early nineteenth century²⁷. The footway in front of the screen is surfaced in flagstones (see paragraph 6.15).

- 6.3. On Clapgun Street the churchyard is bounded by a lime tree avenue, while on Church Lane it is bounded by mixed deciduous trees. The churchyard contains three mid-nineteenth century cast iron lamp posts; they are grade II listed. Tombs survive including the Bakewell family tombs to the south of the porch and a group of five tombs to the north of the chancel.

- 6.4. Boundary treatments, mature trees, lamp posts and tombs contribute positively to the character of the conservation area. Headstones have been laid flat and the inscriptions are obscured. Better presentation of the headstones would enhance the character of the conservation area.

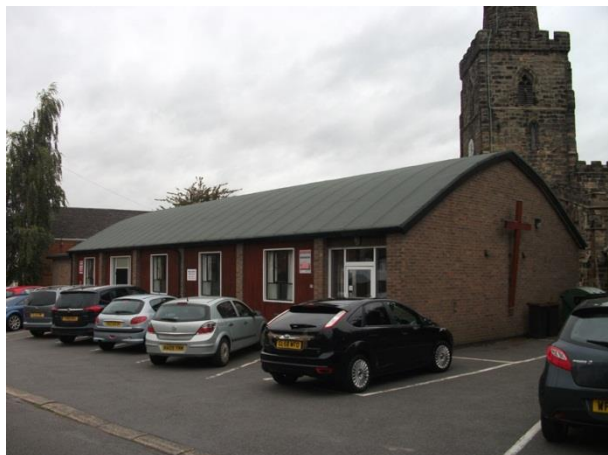
- 6.5. Buildings were demolished c.1921-49 and replaced c.1957 with a church hall²⁸. The church hall does not contribute positively to character. It is laid out behind a car park. It is a single-storey building with a non-traditional roof shape. It uses non-traditional facing and roofing materials. In the short term there is an opportunity to enhance character by introducing a gabled roof and by introducing traditional facing and roofing materials.

a) **Church Hall:** The building is laid out behind a car park. It is a single-storey building with a non-traditional roof shape; it uses non-traditional facing and roofing materials. A replacement building should be laid out to the back of the pavement. It should reflect the conservation area's diverse scale; a two-storey building is likely to be acceptable.

A replacement building should reflect the conservation area's diverse palette of facing materials; red brick or render is likely to be acceptable. It should have a pitched roof covered with plain tiles or natural slate. In the short term there is an opportunity to enhance character through an alteration to the property's roof.

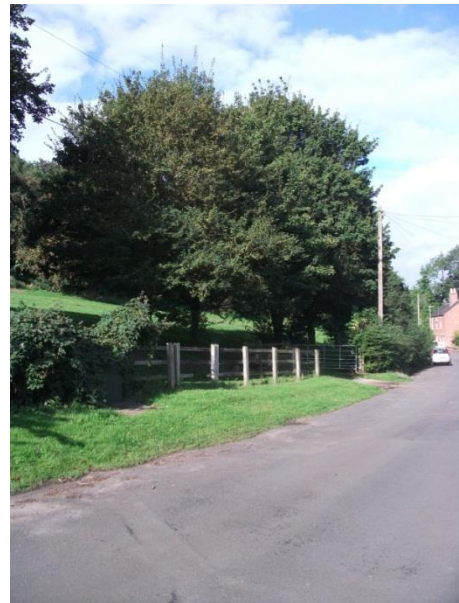
- 6.8. Land on the south side of Spittal has no archaeological interest, but it contributes to the setting of the Spittal 'east' and Spittal 'west' character zones. It contributes a sense of continuity to these zones, which are separated by five houses erected c.1963-72 (Spittal 'centre'). The land is bounded by a stockade fence; at its east end it is retained by a stone wall. These features contribute positively to the character of the conservation area.
- 6.9. The land is bounded by a thorny hedge. The hedge is 'gappy' and outgrown and contains weed species including self-set ash. Proper maintenance of the hedge would enhance the character of the conservation area. The land contains an avenue of field maples; the avenue is well maintained but uncharacteristically uniform.

9.9. At Spittal Hill the avenue of field maples is well maintained but uncharacteristically uniform. There is an opportunity to enhance the character of the conservation area by introducing a more appropriate mix of deciduous species.

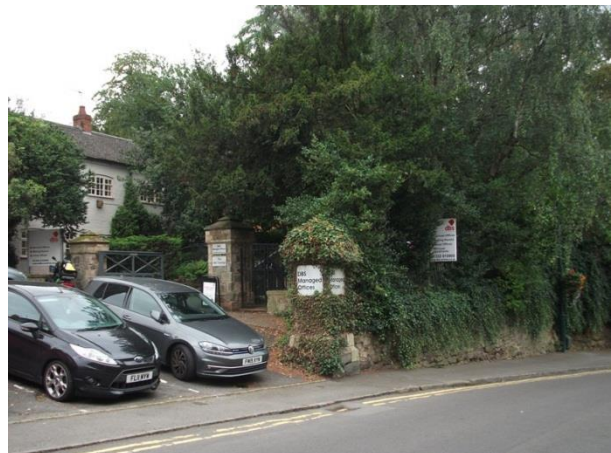
- 6.10. A vicarage was erected in the early nineteenth century, incorporating the remains of an earlier building. Garden land was developed after 1980 with detached houses and an office building. On Delven Lane and Market Street the land is retained by stone walls. On Market Street there is a palisade railing above the retaining wall. Toward the Market Place there are ornate timber gates with square stone piers²⁹.
- 6.11. Toward Delven Lane the land contains deciduous trees including false acacia and hornbeam. Toward Market Street the land contains deciduous trees including sycamore and horse chestnut. The greater part of the character zone is subject to a tree preservation order.

- 6.12. Boundary treatments and mature trees contribute positively to the character of the conservation area. On Delven Lane and Market Street the heads of the retaining walls are obscured by weed species including ivy. On Market Street the land is bounded by an outgrown laurel hedge. Proper maintenance of soft landscaping would enhance the character of the conservation area.

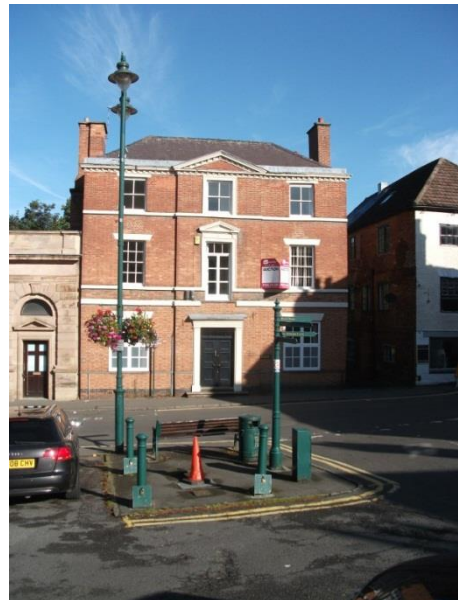
- 6.16. In the Market Place there is a cluster of street furniture including a double lamp column (pictured right). Simplification of this cluster would enhance the character of the conservation area.

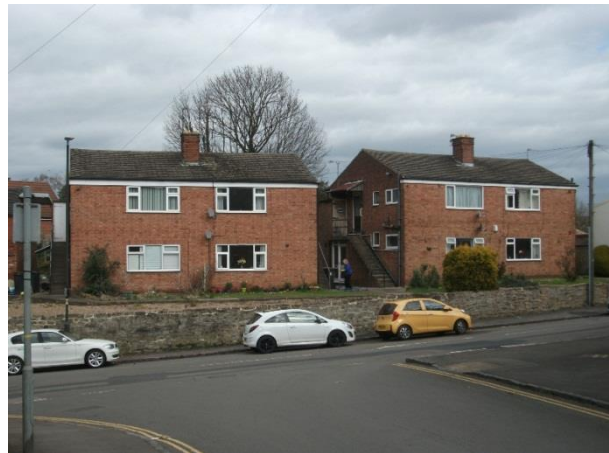
3 to 10 Hollow

- 8.11. In 1958 the Rural District Council permitted the demolition of cottages and the "erection of eight flats" in two detached blocks. The buildings do not contribute positively to character. The buildings are set back from the street behind front gardens; they do not reflect the layout of development in the 'Barroon' character zone. The buildings have non-traditional roof coverings.

- 8.12. In the long term there is an opportunity to enhance character substantially through the replacement of the buildings. The replacement buildings should be arranged in terraced groups and laid out to the back of the pavement. They should have gabled roofs with traditional roof coverings.

- 8.13. The land is wholly within the extent of the castle and partly within the extent of the scheduled monument. Development should conserve the buried remains of the castle. Works affecting the scheduled monument would require scheduled monument consent.

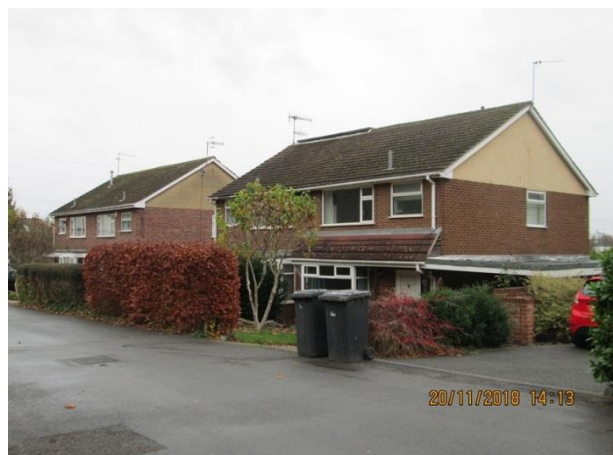
Spittal 'centre'

- 8.14. Properties were demolished c.1963-72 and replaced by a detached house and two semi-detached pairs. The houses do not contribute positively to character. The buildings do not reflect the layout of development in the adjoining character zones. They have non-traditional roof coverings.

- 8.15. In the short term there is an opportunity to enhance character by introducing traditional roof coverings. In the long term there is an opportunity to enhance character substantially through the replacement of the buildings. The replacement buildings should be laid out to the back of the pavement or behind shallow forecourts. They should have traditional roof coverings.

- 8.16. Domestic hedgerows do not contribute positively to character. There is an opportunity to enhance character by replacing these hedgerows with traditional thorny hedgerows.

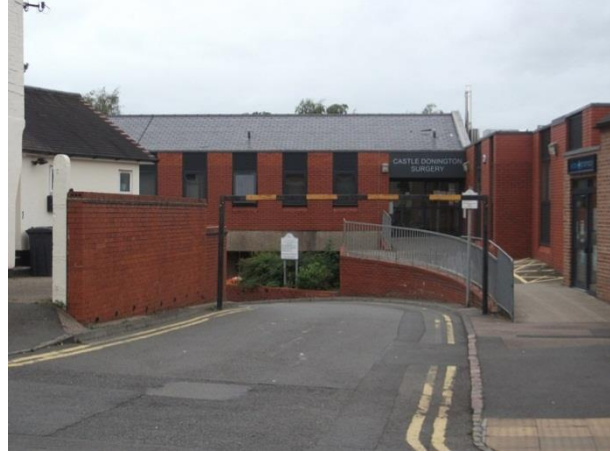
8.17. In 1972 the Rural District Council permitted the demolition of properties and their replacement with doctors' surgeries and a car park. The surgery is set back from the street behind an access drive. It is large and has a uniform appearance; it incorporates a single storey element with a flat roof.

8.18. The building does not contribute positively to character. The building does not reflect the layout of development on Borough Street; the access drive interrupts the continuous frontage. The building does not reflect the conservation area's domestic scale and diverse appearance. The building contributes negatively to views of the parish church spire from Station Road. Mixed tree planting to the rear of the building contributes positively to character.

8.19. In the long term there is an opportunity to enhance character substantially through the replacement of the building. The replacement building should reflect the layout of development on Borough Street and it should restore the continuous frontage. It should reflect the conservation area's domestic scale and diverse appearance. It should have gabled roofs with traditional roof coverings. It should contribute positively to the view of the church spire from Station Road.

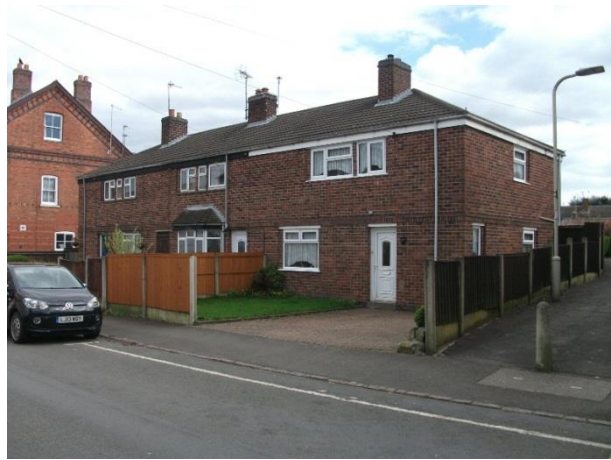
e) **21 to 25 Clapgun Street:** The building (pictured above) does not reflect the layout of the Clapgun Street character zone. A replacement building should be laid out to the back of the pavement.

- 5.32. 21 to 25 Clapgun Street does not contribute positively to character. It is a modern building that does not reflect the layout of the character zone. In the long term there is an opportunity to enhance character substantially through the replacement of the building.

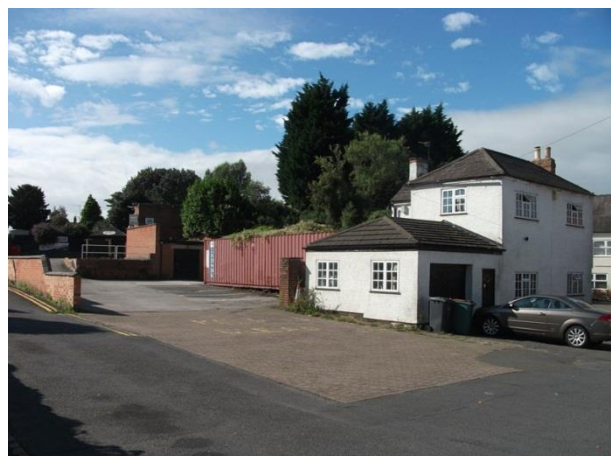
h) **Castle Inn:** The inn was demolished in 1962 and replaced by a surface car park (pictured right). A replacement building should reflect the qualities of the Barroon character zone.

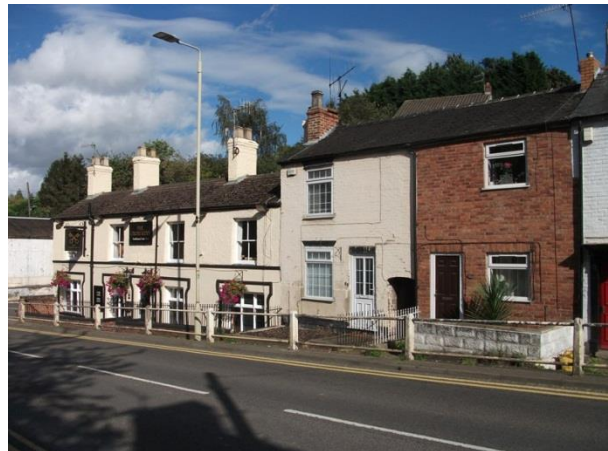
- 9.14. Non-traditional roofing materials intrude throughout the conservation area but in a limited amount. In four character zones non-traditional roofing materials intrude in a greater amount: Bondgate ‘north’, Borough Street, Spittal ‘east’ and Spittal ‘west’. In these character zones there is a substantial opportunity to enhance character through the reinstatement of traditional plain tile and slate roof coverings.
