**SHOP FRONTS AND ADVERTISEMENTS
SUPPLEMENTARY PLANNING DOCUMENT**

ANNEX: TRADITIONAL SHOP FRONT DETAILS

JUNE 2019

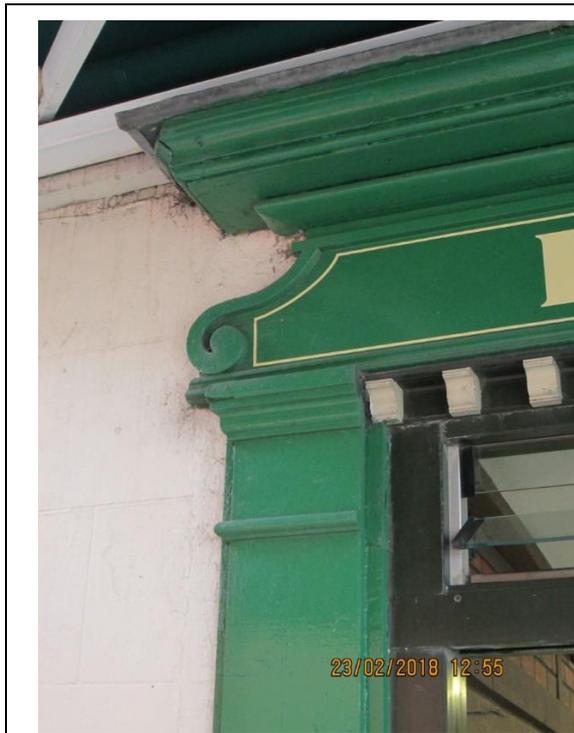
34 Market Street, Ashby. A plain pilaster with a Roman Doric capital carries a frieze with an unusual scrolled edge. The shop display window has been replaced.

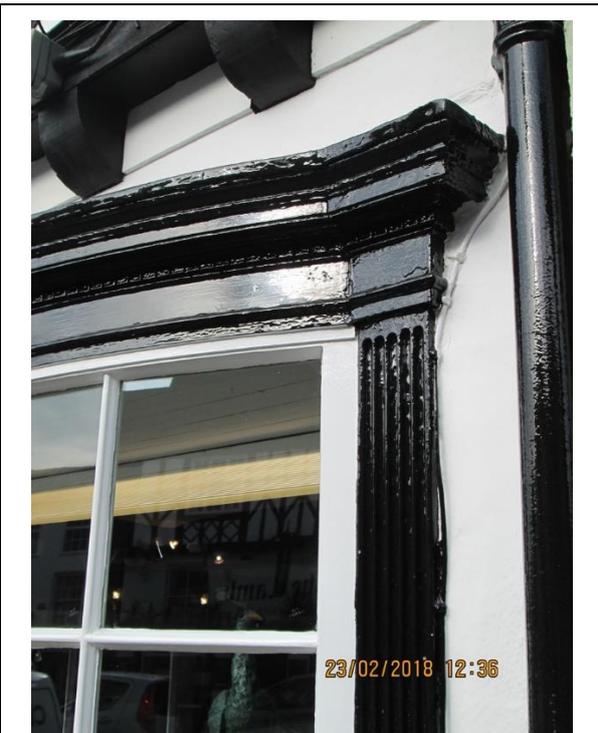
51 Market Street, Ashby. A fluted pilaster with a simple capital supported a shallow frieze and cornice. The shop window is bowed and divided into small panes.

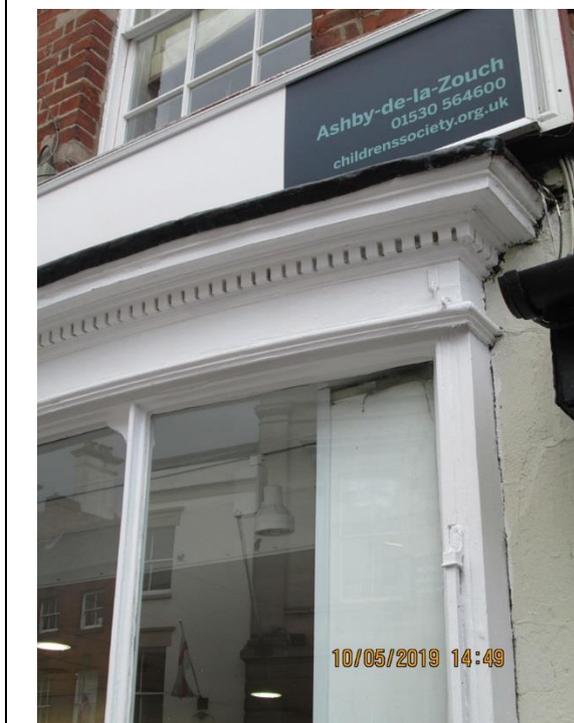
65 Market Street, Ashby. A slim fluted pilaster with no capital carries a frieze and a dentil cornice. The shop window is bowed and contains vertical glazing bars.

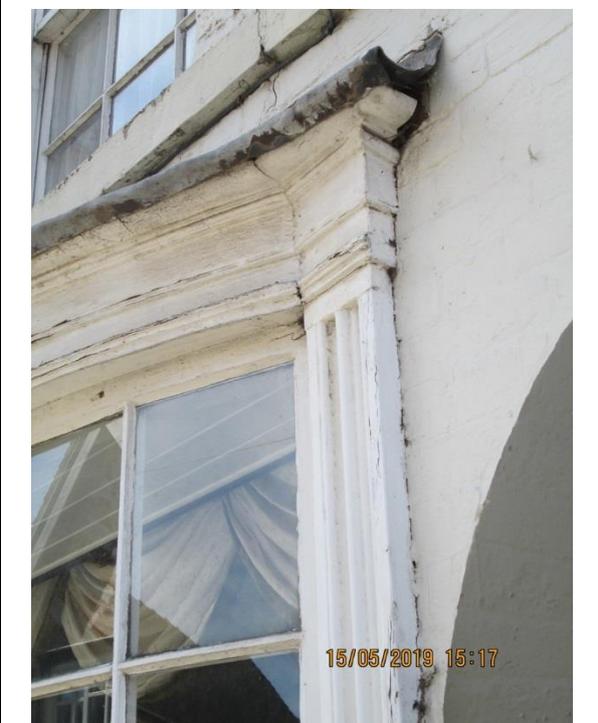
24 Clapgun Street, Castle Donington. A fluted pilaster with a simple capital carries a shallow frieze and cornice. The shop window is bowed and divided into small panes. No longer a shop.

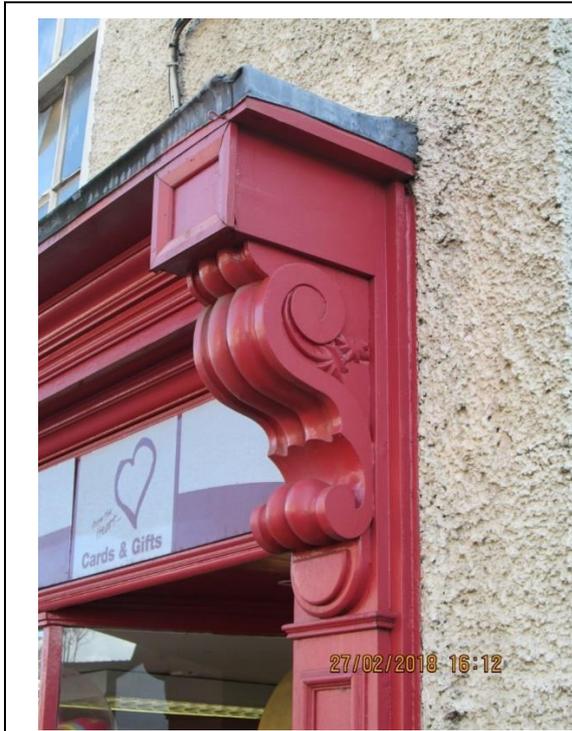
16 Market Street, Ashby. A pilaster with false panelling carries a scroll bracket with a square head. There is a flat fascia with cornice. This shop front has been altered.

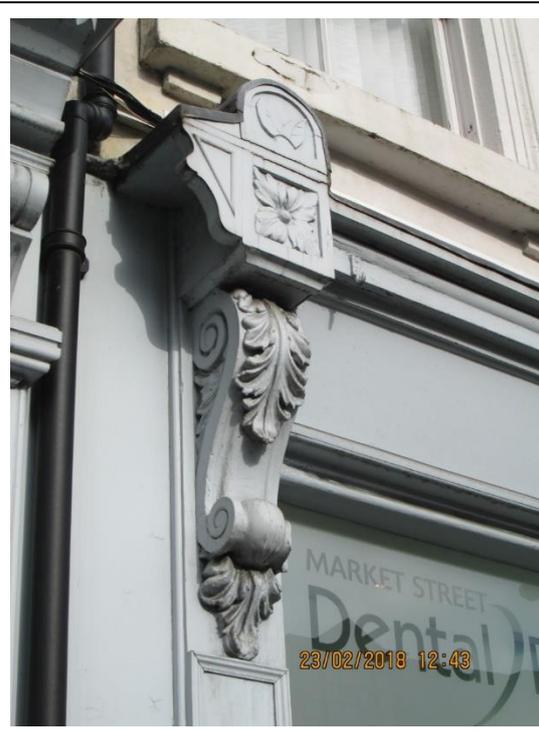
83 Market Street, Ashby. A pilaster with false panelling carries a scroll bracket with a round head. There is a canted fascia. The shop display window has been replaced.

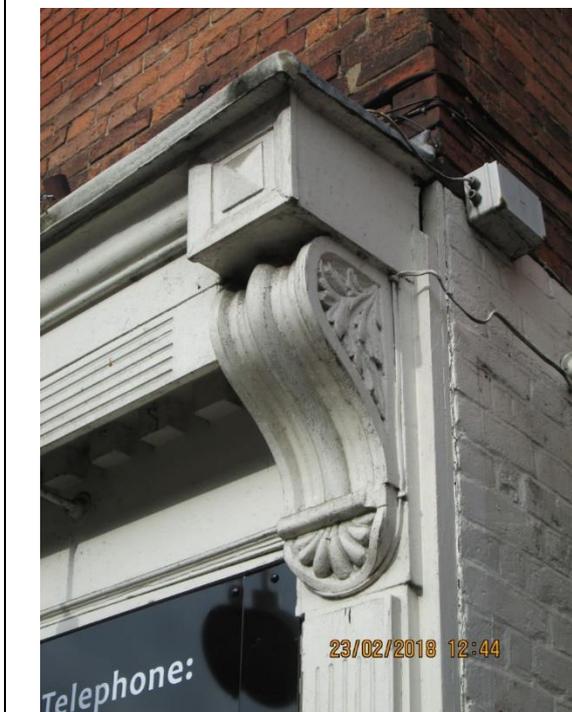
85 Market Street, Ashby. A fluted pilaster carries a scroll bracket with a square head. There is a flat fascia with dentil cornice. The shop display window has been replaced.

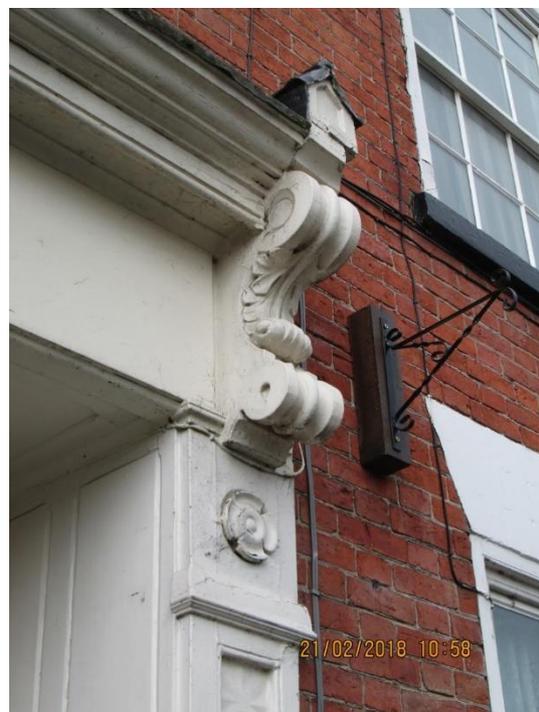
3 High Street, Kegworth. A panelled pilaster with a capital carries a scroll bracket with a gabled head. There is a flat fascia with cornice. Note the panelling in the door recess.

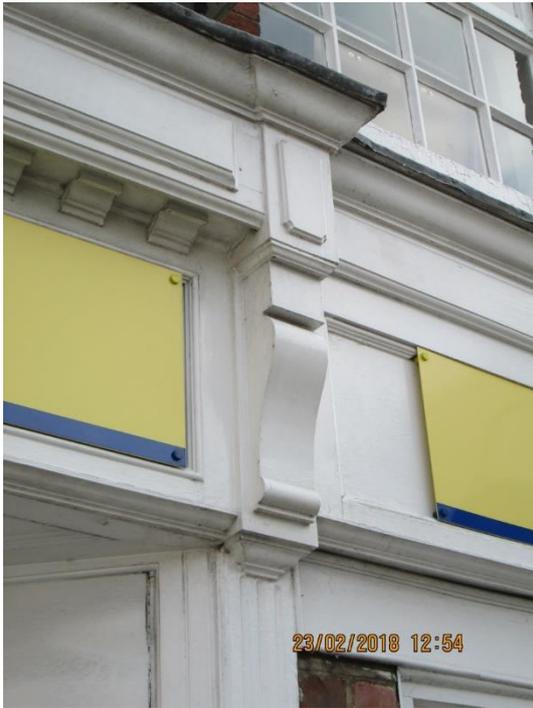
34A Market Street, Ashby. c.1930. A fluted pilaster carries a simple scroll bracket. The cornice is advanced over the head of the bracket. There is a flat fascia.

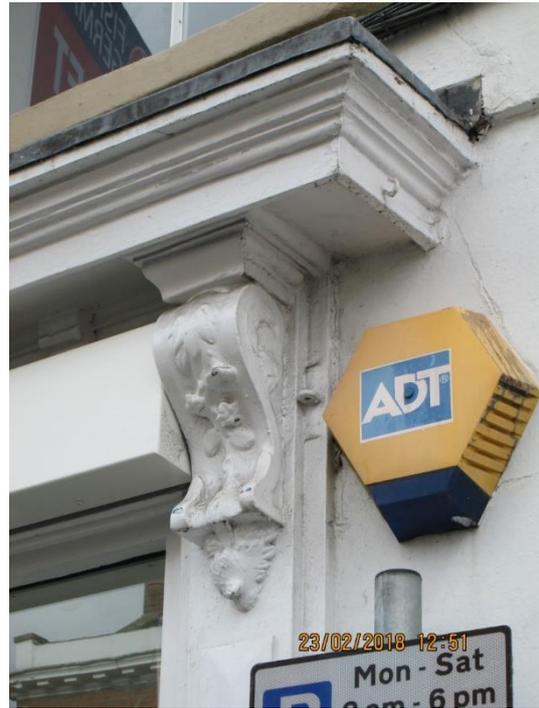
70 Market Street, Ashby. A pilaster with a raised panel carries a scroll bracket; it does not break through the cornice. This shop front has been altered; the fascia is obscured.

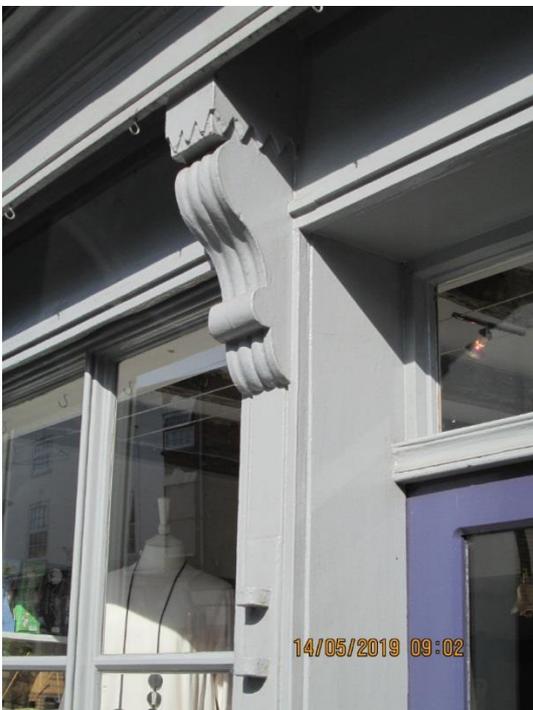
33 Borough Street, Castle Donington. An incised pilaster carries a scroll bracket; it does not break through the cornice. There is a flat fascia. Note the vertical glazing bar.

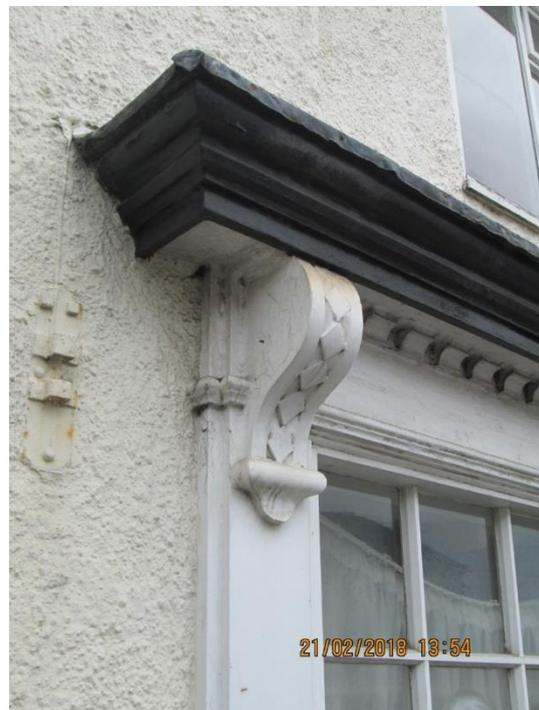
43 High Street, Measham. A plain pilaster carries a scroll bracket; it does not break through the cornice. The shop display window has been replaced. No longer a shop.

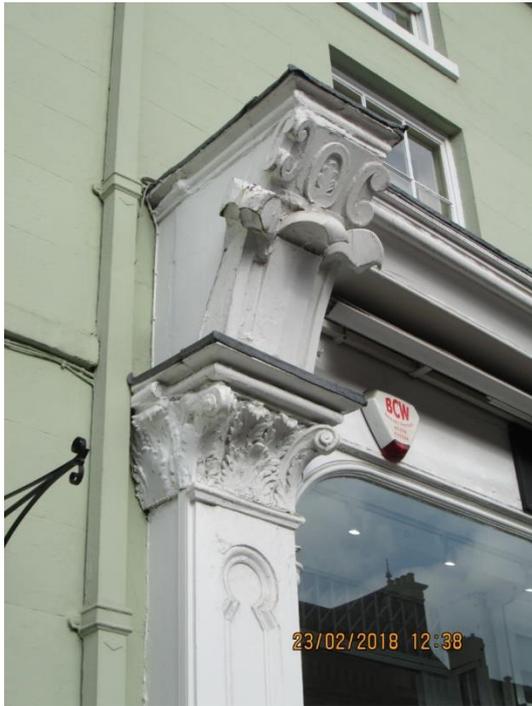
53 Market Street, Ashby. A panelled pilaster with a corinthian capital carries an unusual bracket with a flat head. There is a flat fascia with a box cornice. An ornate shop front.

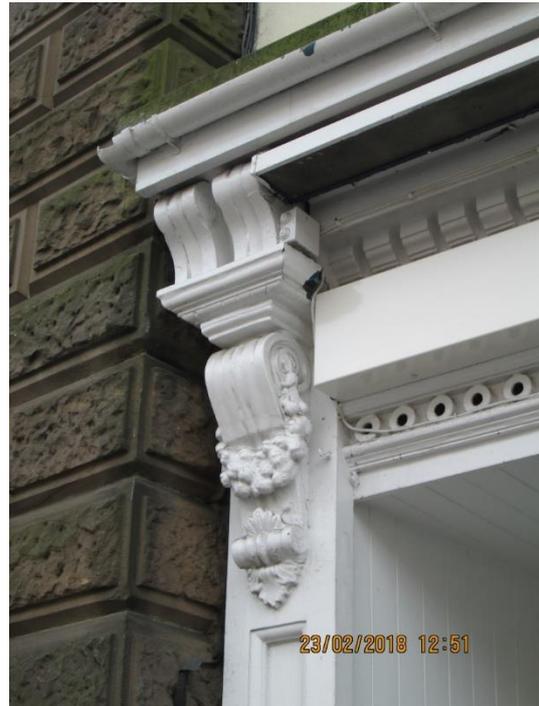
72 Market Street, Ashby. A panelled pilaster carries an unusual bracket; it does not break through the cornice. Altered; the fascia is obscured and the cornice is modern.

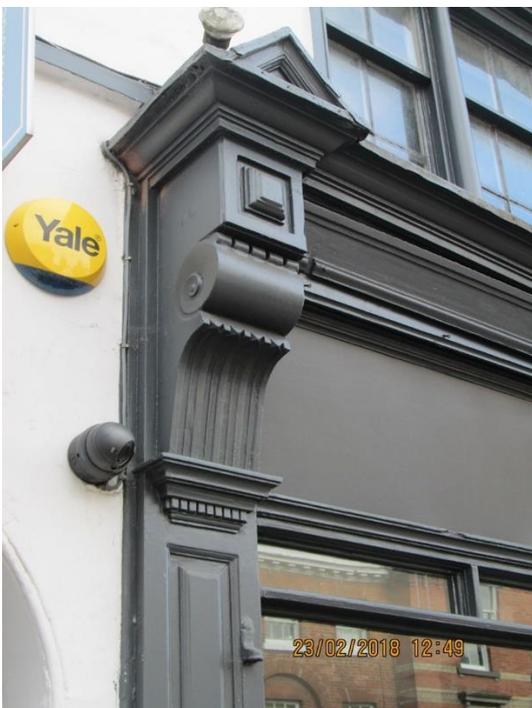
76 Market Street, Ashby. A panelled pilaster carries an unusual bracket with a gabled head. There is a canted fascia. The cornice contains a roller blind.

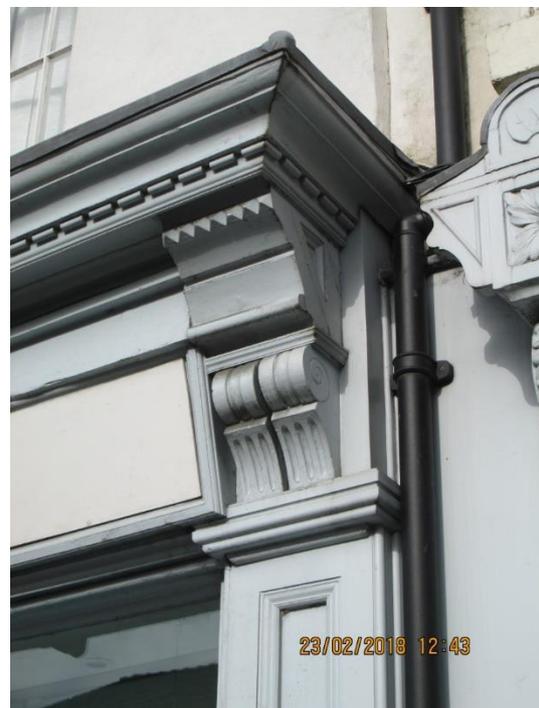
81 Market Street, Ashby. A panelled pilaster carries an unusual bracket; it does not break through the cornice. There is a canted fascia. This shop front has been altered.
